Coatings Consultants, Inc.

LESSON LEARNED

By Bob Cusumano

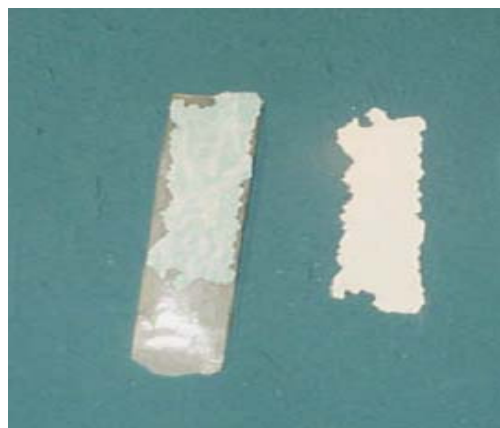
For consulting purposes, the adhesion by tape test should be precisely performed using the prescribed materials. For painting contractors assessing their own work or surfaces they intend to paint, making an X cut with a razor blade, applying a strong masking tape and then sharply removing it will suffice. A pass or fail system can then be used to evaluate the results. Photo 1 shows a result that would definitely be termed a "failed" test.

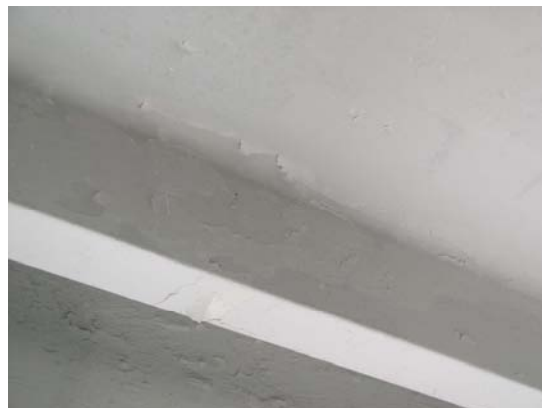
Photo 2

Within six months of repainting, additional peeling of paint was evident (photo 2). This time the analysis included a site inspection. It was determined that some of the delaminating paint chips measured 20 or more mils, indicating that these were areas where the pressure cleaning performed was not aggressive enough to remove all of the marginally adhered existing paint. However, at other locations the delaminated chips only measured 2 to 3 mils, indicating that only the new paint peeled. Again, there was heavy chalk on the rear of all of the delaminated chips and in all instances a white paint remained on the concrete. A black cloth was repeatedly wiped against the now exposed white paint and each time a significant amount of chalk was transferred to the cloth. What had happened? The base coat of paint was so badly degraded that it was “dusting”. When chips were removed and measured with a microscope, it was determined that the chalk was 8 to 10 mils thick! Penetrating masonry conditioner will only penetrate a mil or two and therefore could not satisfy this thick chalk level. It was like trying to paint a beach!

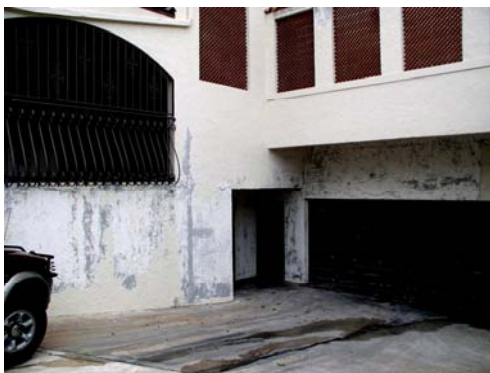
Photo 3

The second incident involves painting the exterior of a four story condominium with elastomeric coating. The specifications stated that all loose existing coating was to be removed by pressure cleaning with a minimum of 3,000 PSI. The contractor pressure cleaned the building with some existing coating being removed. The specified masonry conditioner had been discontinued, so the contractor thinned some of the finish coat, supposedly at a paint salesman’s suggestion, to use as a primer where chalky. When the building was ready for a final inspection, spontaneous peeling had already begun. Adhesion tests were then performed and they revealed that there was poor coating adhesion at most areas of the building. It was recommended that the painting contractor pressure cleaned the exterior of the building again using a turbo tip. Photos 3 and 4 show that a majority of the newly applied elastomeric coating was removed. The building had to be primed and refinished; definitely not good for the contractor’s wallet!

Two mistakes were made here. First, the pressure cleaning originally performed was not aggressive enough to remove poorly and marginally adhered existing paint. It was more of a wash down. Second, the thinned down elastomeric coating was an improper primer because it does not penetrate through any surface chalk to provide a sound base for the final coat.

The moral of the story is that both of these failures could have been avoided if a few simple adhesion tests had been performed on test areas. The results would have indicated that the preparation and priming performed did not provide satisfactory results. A razor blade and tape; that simple test could have saved thousands of dollars.
