Coatings Consultants, Inc.

DANGER FROM BELOW

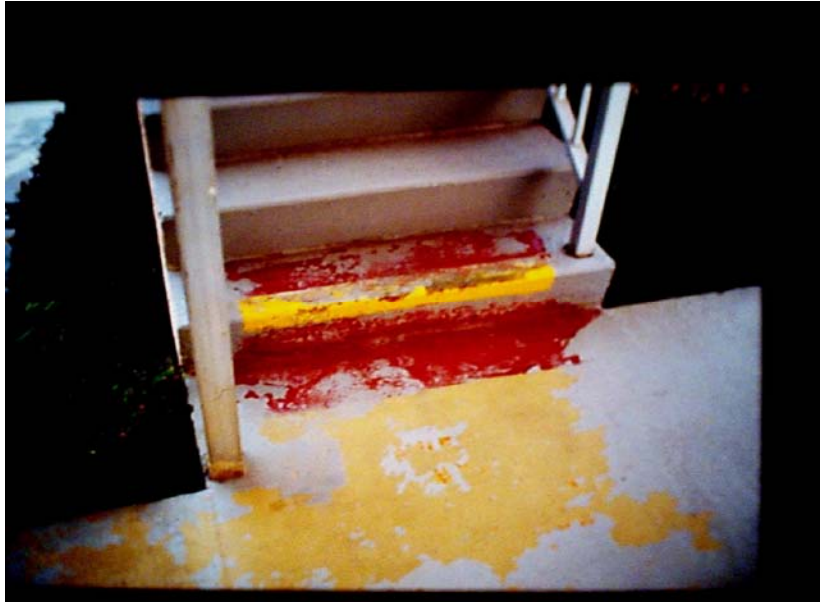
Observations made at the time of inspection revealed that most of the delamination occurred at areas of heavy traffic, including ground floor areas near stairs and the outer perimeter of ground floor walkways. Only isolated spots had failed on the second and third floors. The photograph below depicts the typical conditions found.

Now you know why they wanted to change the colors; that yellow and red combination just doesn't cut it!

The cause of the paint delamination at the Royal Palms was moisture migrating through the concrete walkway. The moisture could pass through the silicone acrylic stain, but was stopped at the alkyd/ stain interface. Because the moisture could not escape, delamination resulted. The moisture readings were low where the paint had peeled because the water was no longer trapped. Examination of the site indicated that there were sprinklers adjacent to ground floor walkways, a constant source of moisture. As is common, there was no vapor barrier beneath the concrete walks. pH testing on the rear of the delaminated paint chips yielded alkaline results, confirming moisture migration as the cause of the problem.
