Coatings Consultants, Inc.

HERE'S THE RUB

By Bob Cusumano

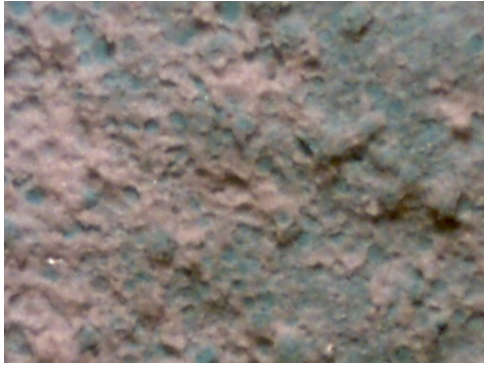
Photo 1

Some would describe this failure as a paint adhesion problem, but its actually a cohesive failure of the drywall texture beneath the paint. If a piece of masking tape is placed on the painted drywall and sharply pulled, then the paint is removed from the drywall. In this instance, light blue paint had been applied to the walls. Examination of the back side of the delaminated paint shows that white texture is attached to the rear of the paint as shown in photo #1. This is confirmed to be texture when a drop of acid is placed on the surface and violent fizzing occurs (photo #2).

What's occurring on this project is that when water is applied to the painted drywall surface for the purpose of removing scuff marks, it penetrates through the paint into the drywall texture beneath. The drywall texture is re-emulsified, and the paint literally floats from the surface. The cause of the problem is the water sensitivity of the texture. This is caused by the fact that not enough resin has been used in the texture. I've had some cases where all living units in a complex were equally affected. In other cases, only some of the units had this problem. Upon further investigation, some texture installers mix up a large bulk batch of texture in the morning initially adding enough acrylic resin to provide a sound texture. After spraying for a few hours, water is added for consistency. After this is done several times throughout the day, and no additional resin is added, the texture loses its hardness and cohesiveness and the failure we've described occurs.

Once paint has been applied to an improper texture, there is little that can be done to improve the performance because the paint acts as a shield against penetration of a different coating. It is possible to predict and prevent this mode of failure. Take a piece of soft black cloth and perform a chalk test by wiping across the surface. If a heavy chalk is transferred to the cloth, then that

surface is likely to be trouble. Wet a cotton ball and rub gently on the texture, if it is easily removed, then the texture is sensitive to moisture. As we've stated in previous articles, it's always wise to do a "patch test" prior to full scale production. If marginal texture is encountered, then treating the surface like a chalky exterior repaint and priming with a penetrating primer can yield good results. Check with your paint manufacturer to determine a suitable primer. Of course, if an extra coat is now required, you should seek additional compensation. As painting contractors, we have enough of our own problems without being burdened by those created by other trades.

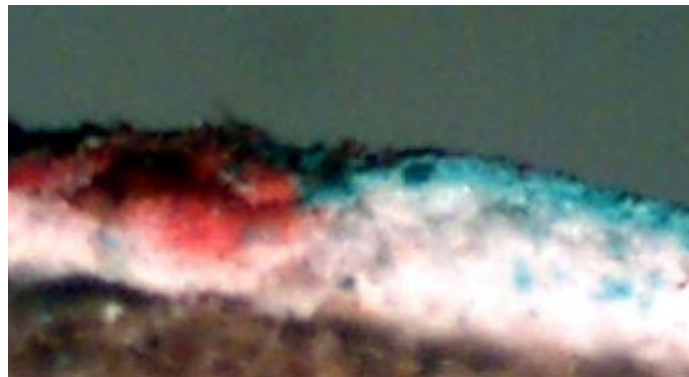
Photo 3

A cotton swab was dipped in red dye and taped to the surface of the drywall. After approximately fifteen minutes, the swab was removed and a section of the paint/drywall composite was extracted using a razor blade. Photo #3 shows a microscopic cross-sectional view. The various colored layers are the blue paint over the white drywall texture over the brown surfacing paper of the drywall. It can be seen that the red dye has penetrated through the paint and into the drywall texture.
