Coatings Consultants, Inc.

HOW MUCH WATER IS TOO MUCH

By Bob Cusumano

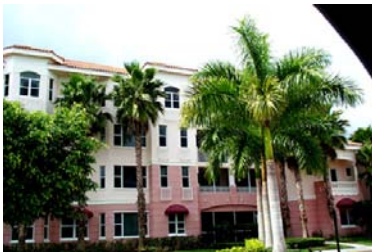
Photo 1

The Manor at Whispering Pines is a luxurious three year old assisted living facility in south Florida. The exterior of the building is panelized stucco construction created by using plastic reveals as shown in photo #1. Water intrusion has occurred within several living units and common areas in the building. The result has been mildewed drywall on the inside of the building that had to be removed and replaced. Attempts at remedial patching and caulking have proved to be unsuccessful.

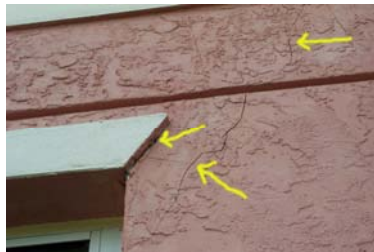
Photo 2

The water intrusion problem was discussed with the building manager whose belief, based on his observations during periods of water intrusion, was that water is penetrating through the stucco itself due to insufficient or improper paint application. During our inspection of the building exterior, we observed several defects such as cracks (photo #2), holes (photo #3), and voids at the ends and at joints between plastic reveals (photo #4) that could also admit water. The blotchy paint appearance as a result of alkali burn shown in photo #5 and the efflorescence depicted in photo #6 are signs of water intrusion.

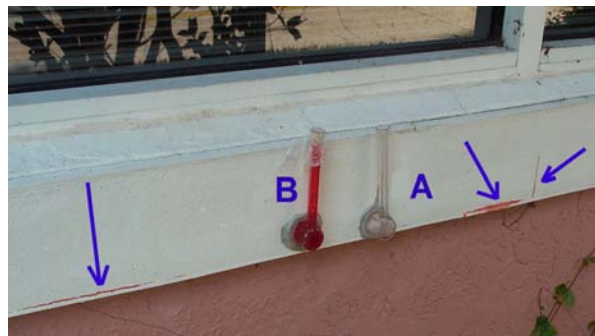
Photo 7

The maximum water absorption rate at each location was calculated. Small stucco core samples were taken at each sample location and examined to determine if water penetrated into the stucco. The Rilem tests performed indicated that the paint system currently applied to the exterior stucco allowed a slight amount of water penetration into the stucco substrate. However, the tests also showed that the amount of water passing through the coating and entering into the substrate is minuscule compared to the amount that can enter through defects in the stucco such as hairline cracks and small voids. Evaluating the test results showed that where stucco defects exist (location A in photo #7) versus adjacent samples where no defects exist (location B), up to 4,000 times more water can pass through a crack or void. Note that the red dye has traveled through the crack system and exited at locations several inches from the Rilem tube.

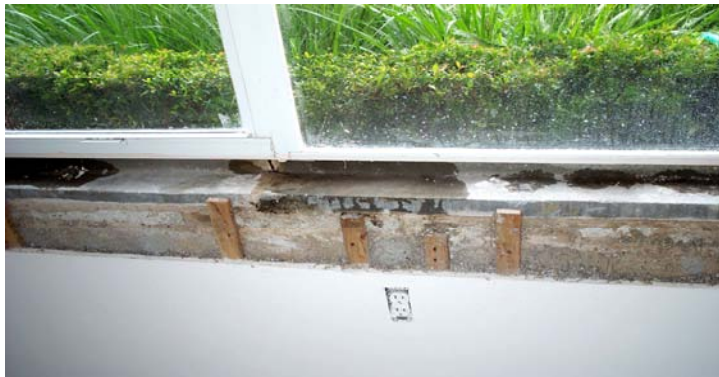
Photo 8

When water was directed at the very top of the frame, where metal to metal and glass to metal joints had not been caulked, a great amount of water intruded into the interior. The water was found to run down the enclosed interior portion of the window frame and drip out the bottom. Water spots appeared on the interior left side of the sill as well as beneath the vertical members that separate the three panes of glass (photo #8). Based on this testing, we were convinced that water is intruding through the window units themselves, not only at the window perimeters and through cracks and voids on the exterior walls.

Remedial work must include repair or replacement of the window units as well as the repair of all stucco defects. Repainting of the building will be necessary due to these repairs, not because of defects in the painting work itself. In this instance, the originally accused painting contractor was exonerated; the window manufacturer and the stucco contractor were not that lucky and will be held responsible for the extensive repairs necessary.
