# Coatings Consultants, Inc.

THEY MAY BE WARPED, BUT THEY'RE NOT FUNNY

By Bob Cusumano

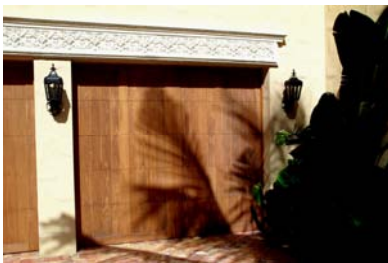
Photo 1

The three garage doors have a southern exposure meaning that they are exposed to the heat of the sun for several hours each day. As shown in photo #1, there is only a one foot return over the doors, so they are directly exposed to the weather. A visual inspection of the doors revealed that the boards are warping exposing the edges as shown by the blue arrows in photo #2. A close up view is shown in photo #3.

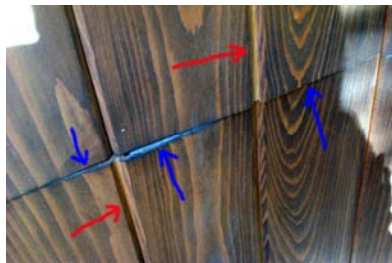
Photo 2

The red arrows in photo #2 and the yellow arrows in photo #4 show that gaps have opened where the boards join at the tongue and groove. Similar conditions were visible on all three doors, but were worse on the easternmost door. The red arrows in photo #5 point to cracks and splits that have developed in the wood.

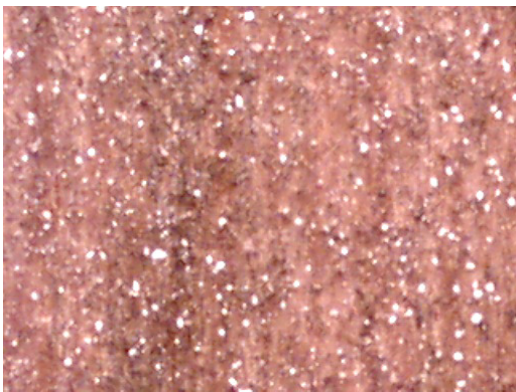
Photo 6

A board was removed from one of the doors in for examination and further testing. The board was examined using a stereo zoom microscope. Photo #6 shows the stained exposed face of the board at a magnification of 60X. The white round specks in the photo appear to be paint over spray on the surface of the door that occurred when nearby surfaces were painted. Photo #7 is a side view showing the penetration of the stain into the wood. The yellow line delineates the outer exposed face of the wood, while the green line indicates the depth of penetration of the stain into the wood. Upon examination, the rear, unexposed face of the wood does have a clear sealer as specified. The ends of the boards have been stained, but are obviously porous due to an open grain.
