Coatings Consultants, Inc.

WHEN IT RAINS, IT STAINS

By Bob Cusumano

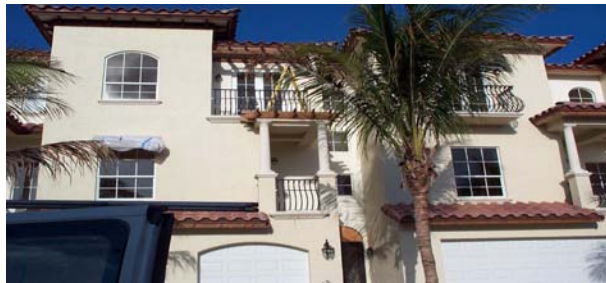
Photo 1

Marina Shores is an upscale residential community on the Intracoastal Waterway. As photo #1 shows, the exterior materials of construction include wood members composed of rough sawn cedar and stucco walls. The exterior wood surfaces are receiving a semi-transparent stain finish. Stucco surfaces are painted with an elastomeric coating system. It was noted that after it rains, a brown discoloration appears on exterior stucco surfaces. These stains seem to lighten over time, but reappear when it rains again. It was theorized that the stains were related to the semi-transparent stain.

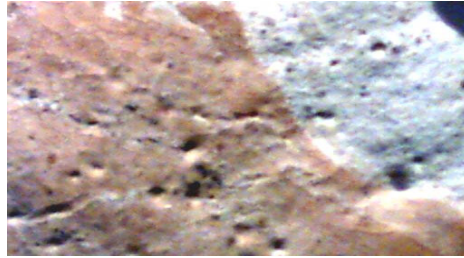
Photo 5

Samples of discolored paint were removed and examined through a microscope. Photo #5 shows the line of demarcation between stained and unstained areas of painted stucco. By viewing a cross-section of the sample, it was established that the discoloration is a deposit on the surface extending into the coating but does not extend throughout the entire thickness of the coating.

Oxalic acid was swabbed onto the deposit, and slight lightening of the discoloration resulted. When dilute hydrochloric acid was applied, a more aggressive acid, the discoloration was removed.

The discoloration at Marina Shores is due to water soluble extractives in the cedar members. Cedar and several other woods have a high percentage of organic materials, including tannins, that are dissolved and leached when exposed to water. When the water evaporates, a brown colored deposit is left on the surface on which the run down occurred.

An attempt can be made to remove the existing deposits using a dilute acid solution. Oxalic, muriatic, and citric can be tried to gauge their effectiveness. Care should be taken to avoid

personal injury and damage to substrates and surfaces treated. If removing the deposits is not effectively accomplished, then affected areas will have to be recoated.

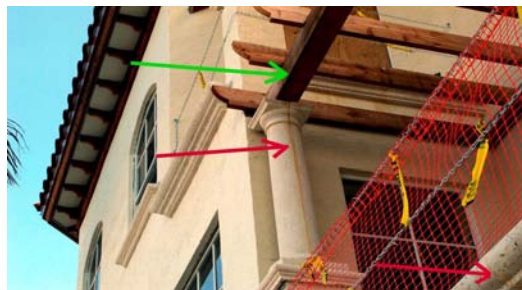
Photo 6

The wood members that are totally exposed to the weather, like the components of the wood trellises, are more prone to have water enter the wood and leach extractives than are the more protected components like wood fascia and soffits. The 6 inch by 8 inch trellis beams (the green arrow in photo #6) are particularly prone to staining due to the greater bulk of material. It was noted that a majority of the stains were located beneath these members on the various buildings.

It should be known that additional staining can occur. Limiting the amount of water that enters and exits the wood members will reduce the amount of discoloration. The semi-transparent stain applied to the wood is relatively porous and does not keep water from penetrating into the wood. A paint film of approximately 4 to 5 mils with an alkyd based primer would be necessary to eliminate water intrusion . However, this would drastically change the aesthetic appearance of the wood and coating delamination could result in some areas. A more practical measure would be to limit the amount of water than can enter the top face of the exposed wood beams. This could be effectively accomplished by installing a metal cap over these surfaces. A more economical, but probably less effective method, would be to apply a coating system that includes the use of a linseed oil primer to the top face of the exposed cedar members.
