Coatings Consultants, Inc.

DROPS FROM ABOVE, BUT NOT HEAVEN

By Bob Cusumano

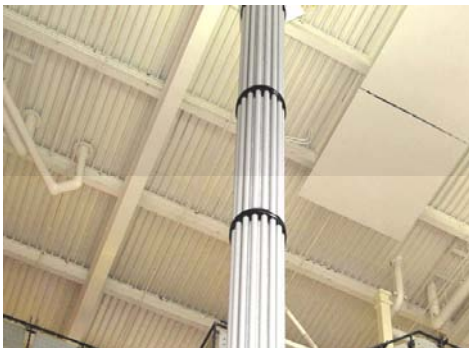
Photo 1

A new classroom building was constructed at a southern university. The atrium area of the building had an exposed steel ceiling composed of galvanized three inch vented ceiling deck with structural steel supporting members (photo 1). Light weight insulating concrete was placed on top of the steel deck thus becoming part of the roofing system. The steel beams and angles were to be shop cleaned and shop primed with an alkyd resin rust inhibitive primer. The galvanized deck and support steel were finish painted with an acrylic dryfall material. Within two years of completion, it was noted that areas of the supporting steel had rusted and delamination of the paint was evident.

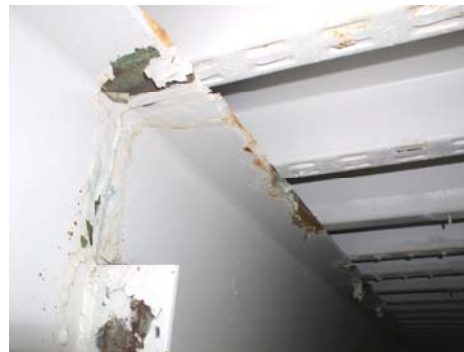
Photo 2

Accessible areas of the exposed ceiling were visually examined and defects were noted. The 12 inch beams in the ceiling appeared to be the most severely affected surfaces, as delaminating paint and corrosion were evident (photo 2). The slotted areas of the corrugated deck were also corroded and discolored. The tops of the 30 inch beams had some corrosion, but none was noticed on the face or bottoms of these beams. Only minute areas of discoloration were noted on pipes in the ceiling area.

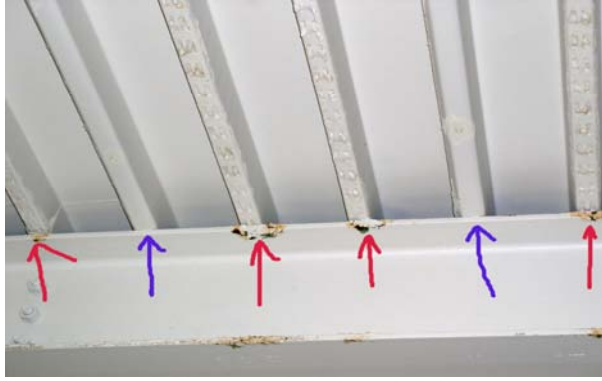
Photo 3

Upon closer inspection, it was noticed that where the deck was vented corrosion was present on the steel below as shown by the red arrows in photo 3. However, the blue arrows in that photo point to areas where no rust occurs on the beams where a solid rib is above. Small, highly alkaline stalactites were present at slots in the deck.

The cause of the saponification was highly alkaline salts that were dripped onto the support steel through slots in the deck and at junctures where two pieces of deck overlap.

It was not determined whether this excess moisture was due to roof leaks or retained moisture in the concrete above the deck. Prior to repainting with a high performance system, it was necessary to determine that the concrete above the deck had sufficiently dried out and that the alkalinity was neutralized.

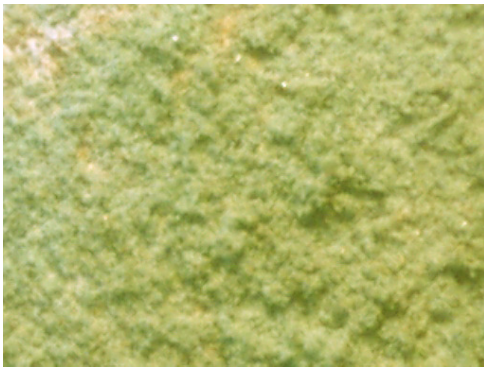
Photo 4

Delaminated paint chips were examined with a microscope. It was found that the rust inhibitive primer had become very friable and easily disintegrated (photo 4).

A wet sample of rust inhibitive primer and the delaminated paint chips were tested to determine if the cause of the degradation of the primer was saponification. Saponification is the chemical degradation of a coating due to high alkalinity and moisture. The coating becomes "sticky", then brittle when dried and loses its adhesion. The testing confirmed that saponification of the primer had occurred.

Alkyd resins such as that used in the rust inhibitive primer are particularly subject to saponification. The degradation of the primer resulted in spontaneous paint delamination and corrosion.

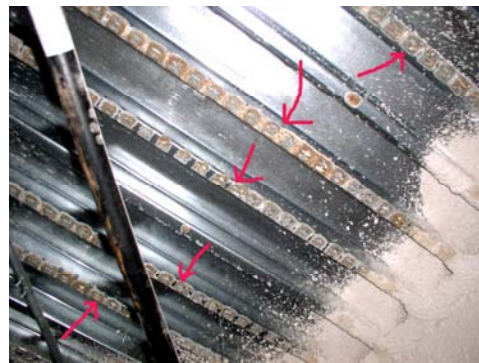
Photo 5

An area of unpainted ceiling deck above an acoustical tile ceiling was also examined. As shown in photo 5, corrosion was apparent at slotted portions of the corrugated ribs at these unpainted areas.
