Coatings Consultants, Inc.

PEELING CEILING

By Bob Cusumano

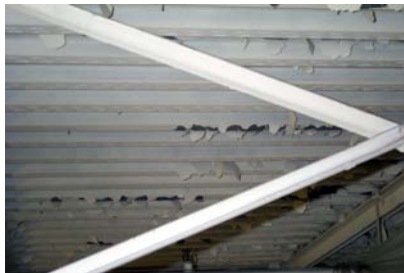
Photo 1

A visual inspection of the painted ceilings revealed that the paint was peeling from galvanized metal ceiling decks (photo #1) and galvanized metal pipes (photo #2), but not from primed steel joists (photo #3).

Infrared spectroscopy confirmed that the paint that had been applied to the exposed metal ceiling surfaces at the gymnasium facility was an alkyd dry fall product. This was contrary to both the painting specifications and the paint submittal made by the paint manufacturer. Unfortunately, when alkyd paint is applied directly to a galvanized surface, then a failure known as

saponification will occur. Saponification is a chemical degradation of the alkyd resin in the paint. Because the steel joists are ferrous metal or steel rather than galvanized and factory primed rather than bare, the alkyd dry fall did not saponify and is well adhered to these surfaces.

Unfortunately for the painting contractor, all of the options for remedial action are costly. All of the paint applied to the galvanized deck, ducts and other surfaces must be removed as applying additional paint on top will only further compromise the adhesion. The options available include hand scraping, power tool cleaning, chemical stripping, and abrasive blasting. All of these options are expensive either due to the low production rates achieved or the extensive cover up of finished floors, walls, and other surfaces that must be accomplished.

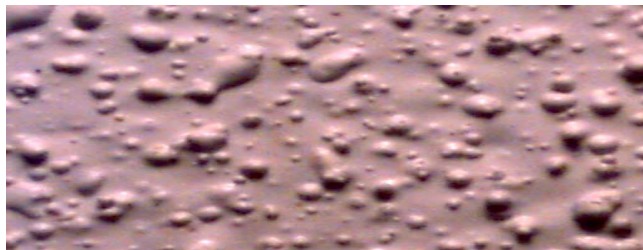
Photo 4

The paint chips were then visually examined using a stereo zoom microscope. No contamination was noted on the rear of the delaminated paint. From examination of the face of the paint chips, it is evident that the paint was spray applied, contrary to the project specifications. Photo #4 is a view at 60X magnification. The round, rough appearance is typical of the spray application of a dryfall paint. Observation of a cross section of the paint indicates that there is only one paint product throughout; that is, individual prime and finish coats could not be discerned and therefore no primer was applied in accordance with the contract requirements.
