ONE FROM COLUMN A

By Bob Cusumano

This case involves a large addition to a mansion on the Florida coast. Part of the job included the construction of a long colonnade walkway that led from the main house to the pool. The roof of the walkway was supported by columns constructed of poured concrete (photo #1).

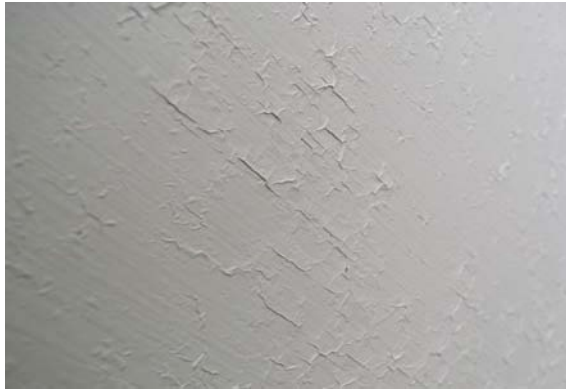
Photo 2

At the time we examined the columns, there was bubbling and wrinkling of the paint at some locations (photo #2) and at other locations, the paint had either already delaminated or been scraped off (photo #3).

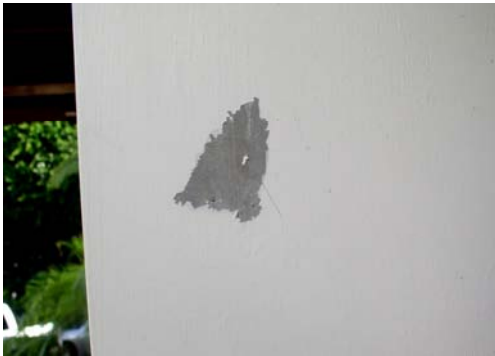
Photo 4

Whenever paint delaminates, it is important to determine where the delamination has occurred. In some instances where the adhesion was poor, the delamination occurred back to bare concrete as shown in photo #4. The surface of the concrete was found to be very smooth at these spots. In other instances, the delamination occurred within the layer of patching material as shown in photo #5.

Another contributing factor to the poor adhesion of the paint to the concrete columns is the lack of mechanical adhesion. A large percentage of paint adhesion is achieved by its mechanical bond to the surface to which it is applied. When that surface is rough and porous, then good adhesion is established. When that surface is smooth and glossy, as it was found to be in this instance, then adhesion is compromised.

1. All paint and patching material should be removed. Unfortunately, large areas of the columns were patched, not just the voids. Scraping is probably the most effective method.
2. All bare concrete surfaces should be acid etched to roughen the surface similar to 120 to 80 grit sandpaper. If the acid does not fizz when applied, then the butcher's wax is interfering with the chemical reaction and must first be removed using solvent. After acid etching, surfaces must be thoroughly flushed with clean potable water, neutralized if necessary, and allowed to thoroughly dry.
3. All pores, voids, and "bug holes" should be patched with a high strength cementitious patching compound, taking care to only fill voids and to remove any excess patching material.

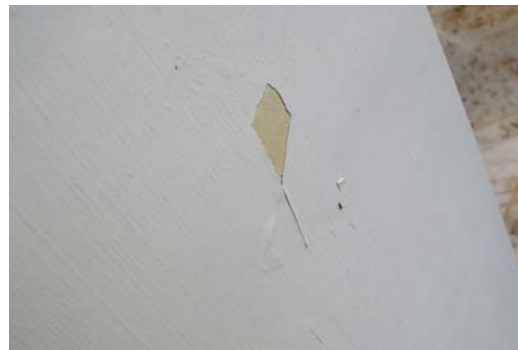
Photo 5

Saponification is one cause of the paint delamination. Saponification is the chemical degradation of a coating due to high alkalinity and moisture. The coating becomes "sticky", then brittle when dried and loses its adhesion. Alkyd and oil base paints are particularly prone to this problem and should not be utilized when moisture and alkali are present. The moisture and alkali have also affected the patching material, causing it re-emulsify and suffer a cohesive failure.
