# Coatings Consultants, Inc.

## DEALING WITH A STICKY SITUATION

By Bob Cusumano

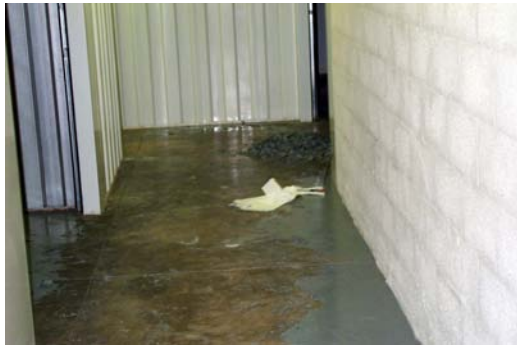
Photo 1

At the time of our inspection, scraping off of the existing applied coating had begun as shown in photo #1. Photo #2 shows the condition of first floor areas prior to scraping; where large areas of paint delamination are visible.

Prior to recoating these floors with either a stain or an epoxy system, all existing coating had to be removed. The surface of the concrete should be roughened, preferably by shot blasting. The pH and moisture levels should be monitored prior to recoating.

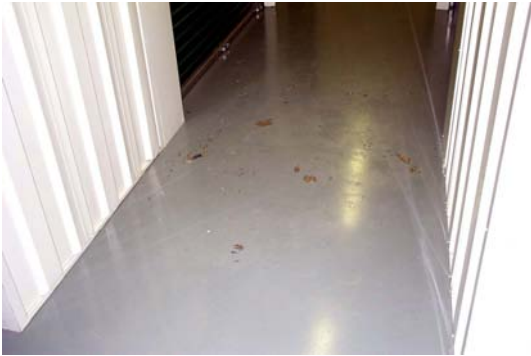
Photo 3

Much of the coating on the second floor appeared to be intact with no delamination. However, at some locations a color and gloss difference was noted which are the initial signs of saponification. On the third floor, delamination was prominent at many areas as typified by photo #3. At some locations there were distinct variations in color and gloss and the coating had become soft and sticky as shown in photos #4.

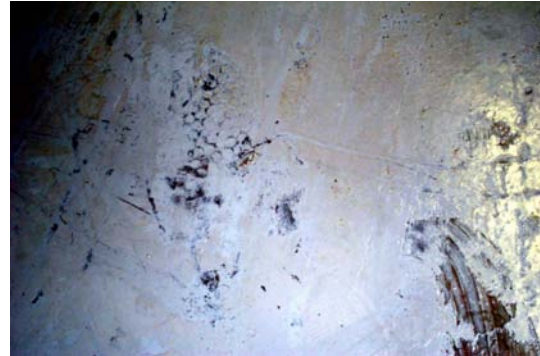
Photo 4

On the third floor, some of the existing coating had become wet and “sticky”. This is due to a phenomenon known as saponification that occurs when a combination of moisture and a highly alkaline condition resulting in total chemical degradation of the coating. The high moisture and pH readings at many locations support this contention. Color and gloss changes occur as a part of saponification. Photo #8 shows the deformation to the paint film that occurs.

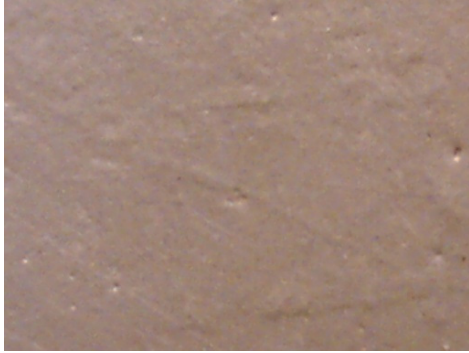
Photo 5

The data sheet for the sealer states that when used as a primer, the product is to be thinned with 1 to 2 quarts of xylene per gallon. The purpose of thinning is to encourage penetration into the concrete and avoid the establishment of a glossy surface. Coatings do not adhere well to a smooth glossy surface as no mechanical adhesion is attained. At this facility, the sealer was applied too heavy, resulting in the top coat of alkyd enamel not establishing good adhesion to the sealer. Photo #5 shows that the rear of the delaminated enamel is extremely smooth. Photo #6 shows that the sealed concrete surface from which the enamel topcoat delaminated is also very smooth with only a few scratches visible from the sanding performed as surface preparation.

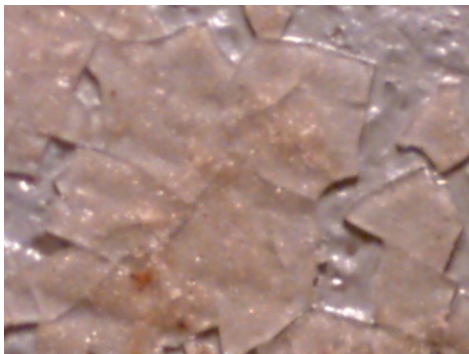
Photo 7

At some locations the sealer lost its adhesion to the bare concrete floor. Photo #7 shows the heavy buildup of sealer with stress cracks visible on the rear of an adhesion test sample. Optical examination of the surface of the concrete at many areas revealed that the surface was extremely smooth and slick. At these locations, the sanding performed was not sufficient to adequately roughen the concrete surface to establish a mechanical adhesion to the substrate. This is supported by many of the pull test results where failure occurred at relatively low pressure removing both the topcoat and the sealer. The floors have a smooth troweled finish. As stated on the sealer data sheet, acid etching of the concrete is recommended in these situations.
