DEALING WITH A STICKY SITUATION

By Bob Cusumano

A national company that owns personal storage facilities around the country recently built a three story building in a southern coastal community. The building was constructed of concrete block and stucco with metal pan ceilings and poured concrete floors.

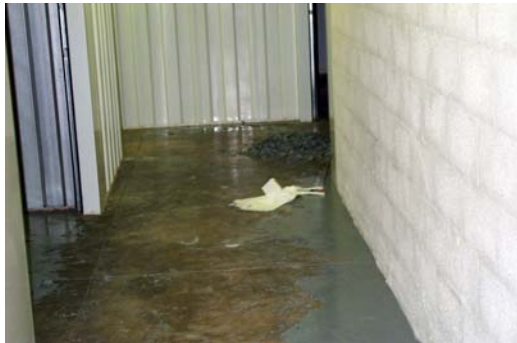
Photo 1

At the time of our inspection, scraping off of the existing applied coating had begun as shown in photo #1. Photo #2 shows the condition of first floor areas prior to scraping; where large areas of paint delamination are visible.

Prior to recoating these floors with either a stain or an epoxy system, all existing coating had to be removed. The surface of the concrete should be roughened, preferably by shot blasting. The pH and moisture levels should be monitored prior to recoating.

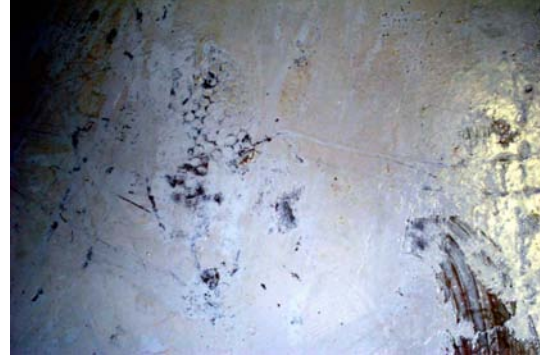
Photo 4

Much of the coating on the second floor appeared to be intact with no delamination. However, at some locations a color and gloss difference was noted which are the initial signs of saponification. On the third floor, delamination was prominent at many areas as typified by photo #3. At some locations there were distinct variations in color and gloss and the coating had become soft and sticky as shown in photos #4.

On the third floor, some of the existing coating had become wet and “sticky”. This is due to a phenomenon known as saponification that occurs when a combination of moisture and a highly alkaline condition resulting in total chemical degradation of the coating. The high moisture and pH readings at many locations support this contention. Color and gloss changes occur as a part of saponification. Photo #8 shows the deformation to the paint film that occurs.

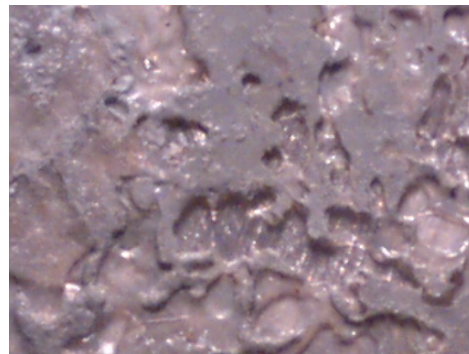
Photo 8

3. Saponification of both the sealer and the alkyd enamel.
