Coatings Consultants, Inc.

LEARNING PROBLEM

By Bob Cusumano

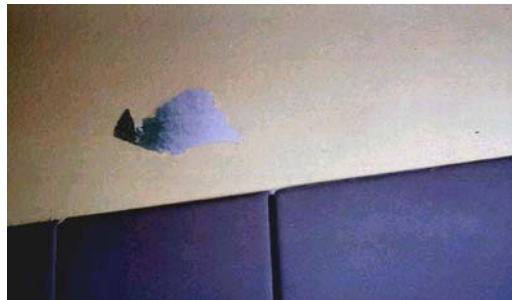
Photo 1

Areas of Building 1 were painted approximately four weeks after plastering was completed. The painting contractor indicated that the material method of application was spray and back roll. Within thirty days of paint application on wall areas of Building 1, bubbles were evident and areas of paint started to peel (photo #1). A short time later, it was discovered that walls in Building 2 had also begun to peel.

The adhesion tests performed indicate that there are many areas where the adhesion of the applied paint is poor and further delamination is likely. In all instances where the adhesion was found to be poor, there was plaster adhered to the rear side of the delaminated paint and the remaining substrate was found to have a heavy to moderate surface chalk.

The testing performed indicates that the paint has adhered to the surface of the plaster, but that the plaster itself has low cohesive strength. The delamination that occurs when adhesion tests are performed is due to fracturing within the plaster itself, not due to poor adhesion of the paint to the face of the plaster. Unfortunately, the application of additional coats of paint at this time, rather than rectify the situation, would in fact worsen it. Each additional coat of paint increases the amount of surface stress. When the stress exceeds the strength of the weakest link of the chain, delamination occurs. In this instance the weak link is the cohesive strength of the plaster.

Had the condition been noted before the paint was applied, the use of a masonry conditioner as a primer would have penetrated and may have added strength to the plaster, thus providing a more suitable surface for painting. Now that paint has been applied, any remedy must include removing the existing paint.

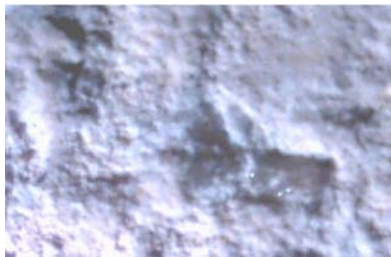
Photo 2

The rear of delaminated paint removed during the adhesion tests was examined using a stereo zoom microscope. The presence of plaster on the rear of all paint samples was readily identifiable due to its crystalline nature (see photo #2) and was confirmed by the violent reaction when a drop of mild hydrochloric acid was placed on the surface (photo #3). Photo #4 shows the rear of the paint sample after the plaster has been removed.
