## RUSTING PROBLEM

By Bob Cusumano

A recent inspection involved a 400 unit apartment complex in south Florida. The manager reported that many of the exterior door frames were showing signs of rusting less than one year after construction of the project was completed.

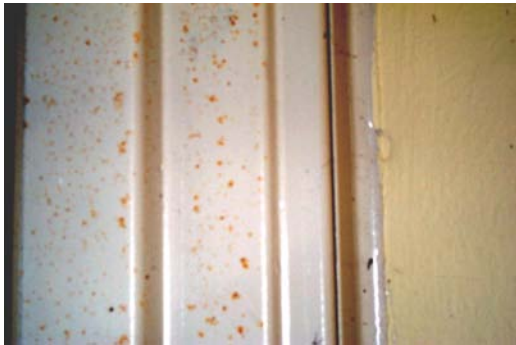
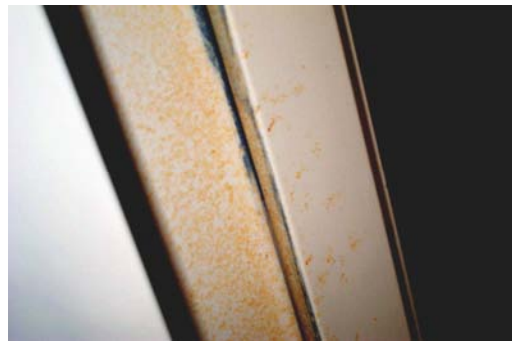
A visual site inspection of the door frames confirmed that a majority of them exhibited varying degrees of rusting, with some being quite severe as shown in photos #1 and #2. Rusting was more severe on the exterior portions of the frame, although some corrosion was also observed on the interior side of these exterior door frames.

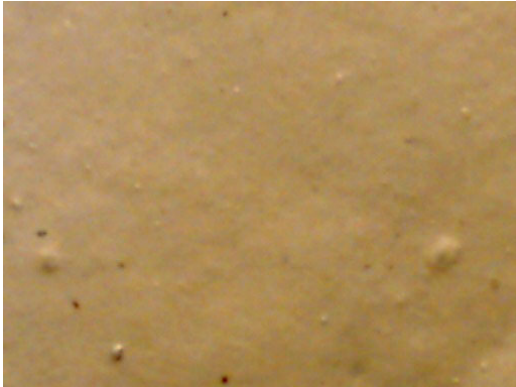
Photo 3

At this point, the questions that needed to be answered were "Did the corrosion develop as a result of defects in the field applied paint coats, thus being the responsibility of the painting contractor?" or "Was the rusting present as a result of improper surface preparation at the shop"? To answer these questions, several frames that did not exhibit visible rusting were selected for testing. The exposed surface of the paint was examined with a stereo zoom microscope and found to be relatively smooth and free of film defects as shown in photo #3.

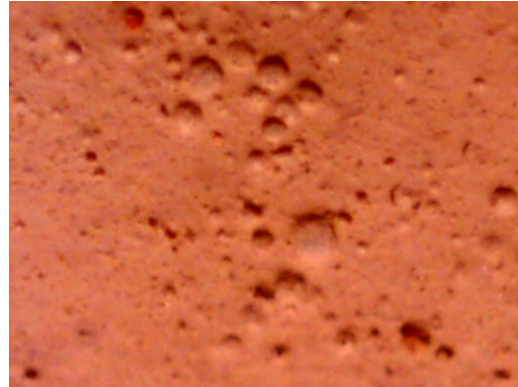
Photo 4

The top coats were then removed using denatured alcohol. This confirmed that the top coats were latex as specified. Alkyd paints and other resins like epoxies and urethane would be unaffected by exposure to denatured alcohol. The now exposed surface of the field applied rust inhibitive primer was found to have several craters, as shown in photo #4, but none of the pores penetrated entirely through that coat of paint. Denatured alcohol did not soften and remove this coat suggesting that it is indeed an alkyd as specified.

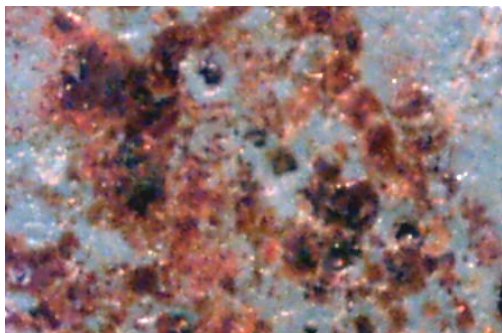
Photo 5

The red field applied primer and the gray factory applied primer were then carefully removed from the steel frame using a razor blade. On the rear of the paint sample, rust was attached to the gray factory primer as shown in photo #5.

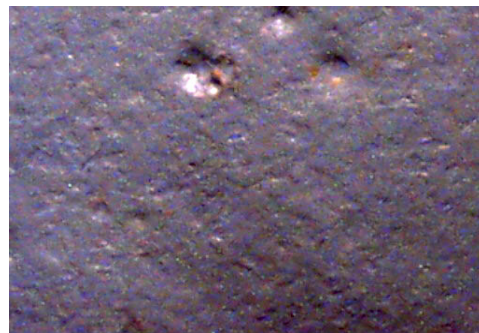
Photo 6

This rust was dissolved by placing dilute hydrochloric acid on the rear of the chip. This reacts with the iron oxide but does not affect the paint. The rear side of the factory primer was then re-examined under the microscope and found to be relatively rough as depicted in photo #6. This

indicates that the primer was applied over rust and mill scale rather than to a smooth surface. Test samples from other frames had similar results.
