Coatings Consultants, Inc.

OUTSMARTING YOURSELF

This month's case history is an example of what problems can occur when you get creative with a project's painting specifications.

A new facility for the maintenance of school buses was recently built in a south Florida city. As a part of the building construction, interior exposed galvanized metal ceilings and related structural steel and metal piping were to be painted. Section 09900 Painting of the project specifications, states that metal surfaces are to be washed and pretreated as required prior to painting. The specification further states that the spray application of paint is prohibited. The painting schedule for interior galvanized metal states that these surfaces are to be primed with one coat of galvanized metal primer and finished with two coats of high gloss latex enamel. The shop primer on ferrous metal surfaces was to be touched up where bare or damaged and these surfaces were then to be painted with two coats of high gloss latex enamel.

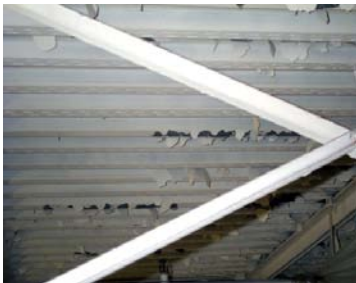
Photo 1

A visual inspection of the painted ceilings revealed that the paint was peeling from galvanized metal ceiling decks (photo #1) and galvanized metal pipes (photo #2), but not from primed steel joists (photo #3).

Based on our observations and testing, the paint applied to the exposed metal ceiling surfaces at the bus maintenance facility was an alkyd dry fall product. It is further our opinion that no primer was applied. When a traditional alkyd paint is applied directly to a galvanized surface, then a failure known as saponification is likely. Saponification occurs when the alkyd resin is

Had a galvanized primer been applied to the galvanized ceiling deck and pipe surfaces, as specified by both the architect and the paint manufacturer, then the delamination from these surfaces would not have occurred. Unfortunately, the painting contractor tried to save a few bucks by applying an alkyd dry fall directly to these surfaces.

Now let's look at the remedial options available, keeping in mind that the facility is now open and must remain so when the work is performed. Obviously, all of the existing paint must be removed from the galvanized ceiling deck and pipes. Potential remedial measures available to the painting contractor include:

1. Hand scraping and/or power tool cleaning - these methods are impractical due to the large size of the ceiling, would be slow and the result in a high labor cost.
2. High pressure water blasting- this method is impractical because there are finished office spaces immediately below failing ceiling surfaces that would be damaged by water intrusion from above and would require extensive cover up.
3. Chemically stripping- this method would be both messy and expensive.
4. Abrasive blasting- must use an abrasive like plastic pellets that will not damage or remove the galvanizing.

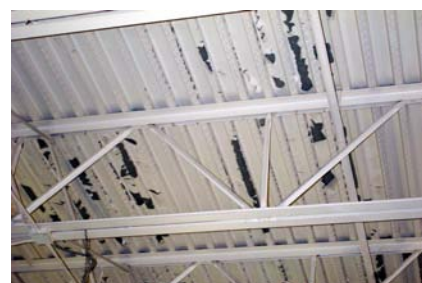
Photo 3

chemically attacked. Because the steel joists are ferrous rather than galvanized and factory primed rather than bare, the alkyd dry fall is well adhered to these surfaces.

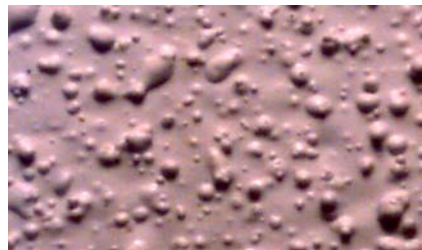
Photo 4

The paint chips were then visually examined using a stereo zoom microscope. No contamination was noted on the rear of the delaminated paint. From examination of the face of the paint chips, it is evident that the paint was spray applied. Photo #4 is a view at 60X magnification. The round, rough appearance is typical of the spray application of a dry fall paint. Observation of a cross section of the paint indicates that there is only one paint product throughout; that is, individual prime and finish coats could not be discerned.
