# Coatings Consultants, Inc.

## THE IMPORTANCE OF ASSESSING ADHESION

By Bob Cusumano

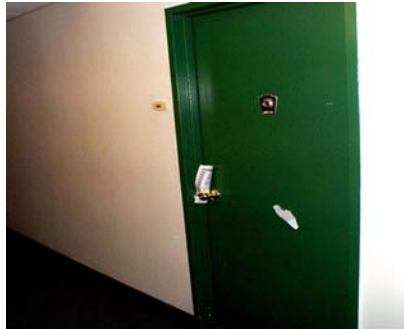
Photo 1

A short time after completion of the painting, it was noted that some doors and frames began to chip and show signs of paint delamination (photo #1). The Association contacted the contractor, expressed its concern and demanded that the situation be assessed and corrected.

Paint chips removed during adhesion tests were visually examined. While the front side of the chips was green, the rear side of the paint samples was gray. This is an indication that the delamination included both the newly applied green enamel and previously applied coating. That is, the new enamel is well adhered to the previously applied gray paint, but that marginal adhesion exists between previous coats.

The cause of this failure is insufficient surface preparation. Because of the marginal adhesion of the existing paint, it was not proper to simply lightly sand the surface and apply additional paint. As a chain is only as strong as its weakest link, a paint system is only as strong as the weakest bond between or within individual coats. In this instance, a majority of the existing paint should have been removed to a sound surface by scraping or stripping. Although this process is tedious and costly, good paint adhesion cannot be accomplished on the existing painted surfaces unless this is accomplished. Each coat of paint over a marginally adhered coating tends to further compromise adhesion of the total applied system due to increased weight and stress.

This costly situation could have been easily avoided by using a very simple tool at every painting contractor's disposal, a pocket knife. One is attached to my key ring and I never assess a repaint job without it. By probing with a knife blade, it is possible to gauge the adhesion of existing coatings. If the paint is difficult to remove and the probing action only removes it at the tip of the blade, then the adhesion is relatively sound. If, however, the paint is easily removed and far exceeds the width of the knife blade then there is cause for concern. There are many instances where no peeling is evident and the existing coating appears to be well adhered, but when tested is found to be otherwise. This is especially true of coatings that have high degrees of cohesion like elastomerics.

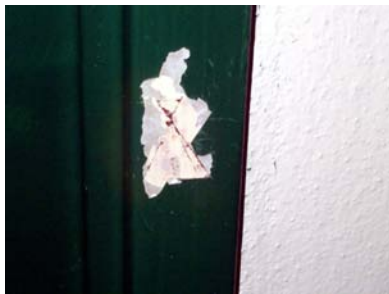
Photo 2

Adhesion tests were performed on randomly selected hollow metal doors and frames that did not exhibit any peeling or coating delamination. These were performed in general accordance with ASTM D3359, Adhesion by Tape Test, Method A. Incisions were made through the coating in an X pattern. A specified adhesive tape is firmly applied to the area and then sharply removed. The adhesion of the coating is then evaluated by the amount of paint that is removed. Photograph #2 show the typical result of the adhesion tests. A great deal of paint could be easily removed using a putty knife as illustrated in photograph #3.
