Coatings Consultants, Inc.

THE IMPORTANCE OF ASSESSING ADHESION

By Bob Cusumano

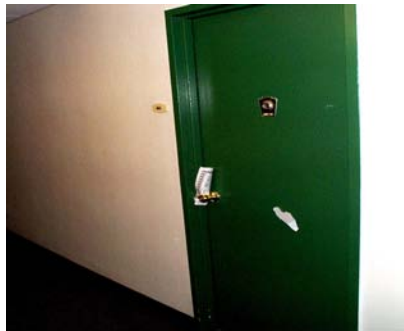
Photo 1

A short time after completion of the painting, it was noted that some doors and frames began to chip and show signs of paint delamination (photo #1). The Association contacted the contractor, expressed its concern and demanded that the situation be assessed and corrected.

Paint chips removed during adhesion tests were visually examined. While the front side of the chips was green, the rear side of the paint samples was gray. This is an indication that the delamination included both the newly applied green enamel and previously applied coating. That is, the new enamel is well adhered to the previously applied gray paint, but that marginal adhesion exists between previous coats.

The cause of this failure is insufficient surface preparation. Because of the marginal adhesion of the existing paint, it was not proper to simply lightly sand the surface and apply additional paint. As a chain is only as strong as its weakest link, a paint system is only as strong as the weakest bond between or within individual coats. In this instance, a majority of the existing paint should have been removed to a sound surface by scraping or stripping. Although this process is tedious and costly, good paint adhesion cannot be accomplished on the existing painted surfaces unless this is accomplished. Each coat of paint over a marginally adhered coating tends to further compromise adhesion of the total applied system due to increased weight and stress.

This costly situation could have been easily avoided by using a very simple tool at every painting contractor's disposal, a pocket knife. One is attached to my key ring and I never assess a repaint job without it. By probing with a knife blade, it is possible to gauge the adhesion of existing coatings. If the paint is difficult to remove and the probing action only removes it at the tip of the blade, then the adhesion is relatively sound. If, however, the paint is easily removed and far exceeds the width of the knife blade then there is cause for concern. There are many instances where no peeling is evident and the existing coating appears to be well adhered, but when tested is found to be otherwise. This is especially true of coatings that have high degrees of cohesion like elastomerics.

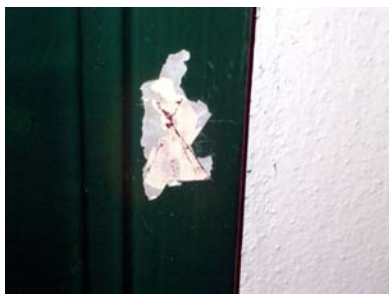
Photo 2

Adhesion tests were performed on randomly selected hollow metal doors and frames that did not exhibit any peeling or coating delamination. These were performed in general accordance with ASTM D3359, Adhesion by Tape Test, Method A. Incisions were made through the coating in an X pattern. A specified adhesive tape is firmly applied to the area and then sharply removed. The adhesion of the coating is then evaluated by the amount of paint that is removed. Photograph #2 show the typical result of the adhesion tests. A great deal of paint could be easily removed using a putty knife as illustrated in photograph #3.
