Coatings Consultants, Inc.

ADHESION VERSUS SCRUBBABILITY

By Bob Cusumano

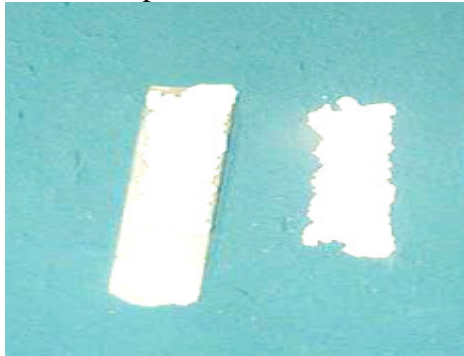
Photo 1

Examination of the back side of the delaminated paint shows that white texture is attached to the rear of the paint as shown in photo #1.

Examination of the wall area where the test was conducted revealed that part of the texture was still present on the wall. Therefore rather than an adhesion problem, that is the paint losing its bond to the texture, we really have a cohesion problem within the drywall texture itself. In this instance the adhesion of the paint to the texture was stronger than the cohesive force that holds the texture together.

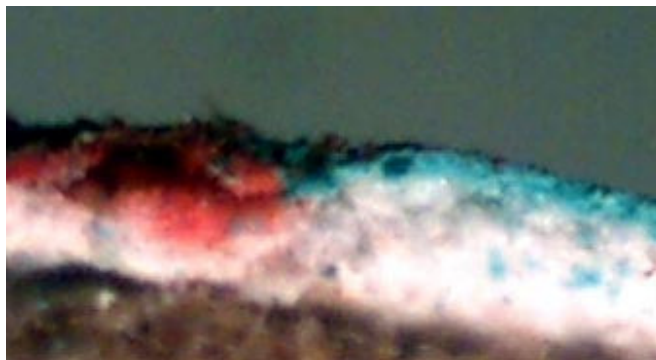
Photo 2

When the paint over the drywall texture is undisturbed, the cohesion of the texture is sufficient to prevent spontaneous delamination of the paint. However, when the painted drywall is stressed by the action of scrubbing, then delamination occurred. It was also theorized that the absorption of water during the scrubbing process was a factor in the failure. To confirm this condition, a cotton swab was dipped in red dye and taped to the surface of the drywall. After approximately fifteen minutes, the swab was removed and a section of the paint/drywall composite was extracted using a razor blade. Photo #2 shows a microscopic cross-sectional view. The various colored layers are the blue paint over the white drywall texture over the brown surfacing paper of the drywall. It can be seen that the red dye has penetrated through the paint and into the white drywall texture.

What's occurring on this project is that when water is applied to the painted drywall surface for the purpose of removing scuff marks, it penetrates through the paint into the drywall texture beneath. The drywall texture is re-emulsified, and the paint literally floats from the surface when it is scrubbed. The cause of the problem is the low cohesion and water sensitivity of the texture.

In this instance, not enough acrylic resin was used in formulation of the texture. Similar failures occur when wallcovering is applied. The water in the paste wets the texture and the inherent stress of the wallcovering causes delamination.

Once paint has been applied over a weak texture, there is little that can be done to improve the overall performance because the paint already applied acts as a shield against the penetration of any additional coating. It is however, possible to predict and prevent this mode of failure. Before painting any textured surface, take a piece of soft black cloth and perform a chalk test by wiping across the surface. If a heavy chalk is transferred to the cloth, then that surface is likely to be trouble. Wet a cotton ball and rub gently on the texture, if it is easily removed, then the texture is sensitive to moisture. As we've stated in previous articles, it's always wise to do a "patch test" prior to full scale production. If marginal texture is encountered, then treating the surface like a chalky exterior repaint and priming with a penetrating primer can yield good results. Check with your paint manufacturer to determine a suitable primer.
