Coatings
Consultants
Inc.

SOMETIMES IT'S NOT GOOD TO SHINE

By Bob Cusumano

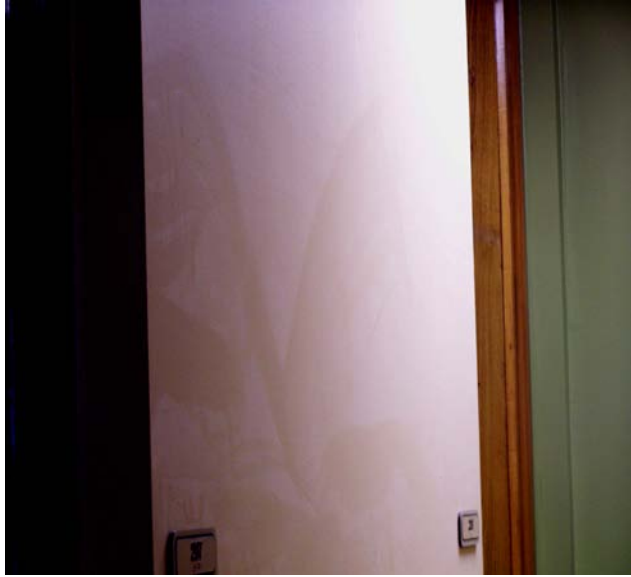
Photo 1

The work was completed and ready for the beginning of the fall semester. A few months later, it was determined by maintenance personnel that many wall areas had developed an uneven appearance. A visual inspection of several buildings confirmed that some wall surfaces had a mottled appearance as shown in photographs 1 and 2. At these locations, some wall areas appeared to be flat, while other portions were shiny. Walls in some of the building were unaffected and had an even appearance.

Based on the observations made and the testing performed, it was determined that burnishing is the cause of the mottled appearance of the paint in some buildings resulting in a difference of surface gloss. Burnishing is a term referring to glossy or shiny spots on a painted surface caused by rubbing, washing, wiping or scrubbing the surface of the paint. This causes the surface to “polish” resulting in a higher sheen than adjacent surfaces. An individual paint’s susceptibility to burnishing is based on a number of factors including amount and types of pigment, type of resin, types of colorants used, etc. Burnishing as the cause of the problem is consistent with the observation that the paint originally had an even appearance, but was affected by wiping with a cloth, a situation that would develop over time as walls are subjected to cleaning.

Whenever you are using new products, particularly dark colors, it is wise to make drawdown samples. After the paint cures, rub the samples with soft cloth. If a shine develops, then be aware that a burnishing problem may result.

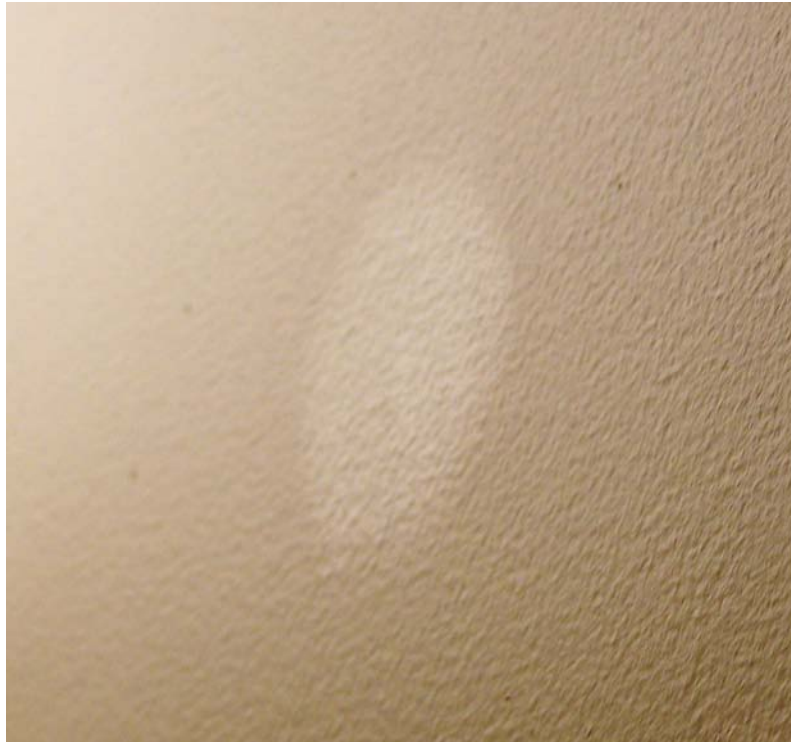
Photo 3

A black cloth was wiped on a portion of the mottled wall that appeared to be flat and photo 3 shows the result. The rubbed spot appeared to be lighter in color and more glossy than it had been originally. Microscopic examination of the cloth revealed that a small amount of material was transferred to the cloth. This procedure was repeated at similar locations with the same result.
