## LOOK BELOW THE SURFACE WHERE DANGER LURKS

By Bob Cusumano

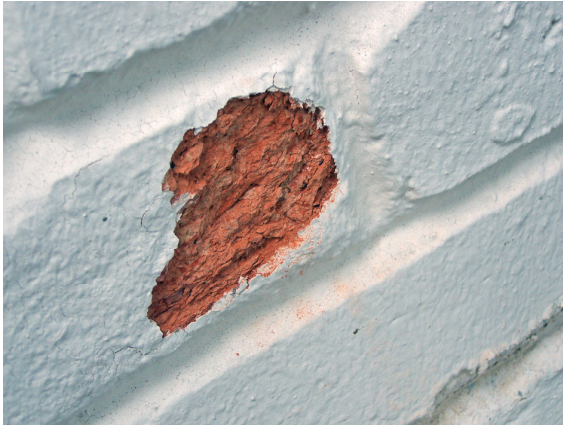
Photo 1

The Able Painting Company had the contract to paint the exterior of a two story oceanfront condominium building. The exterior walls are brick that were previously unpainted since the building was built twenty years ago. Able pressure washes the building with a chemical to remove chlorides, applies the specified masonry conditioner, and finishes the brick with a special coating designed to be applied to brick surfaces. When Able leaves the job, the building looks great. Unfortunately a few months later the residents complain that some peeling is occurring as shown in photo 1. Adhesion tests are performed and at locations where the coating delaminates, the rear of the delaminated material is examined. In all instances, there is brick attached to the rear of the coating as shown in photo 2. The cause of the coating delamination is a cohesive failure of the brick rather than an adhesive failure of the coating to the brick. The coating adhered well to the brick, but chunks of brick have easily broken off. Fortunately, the adhesion tests indicate that areas where the brick is spalling are isolated and that adhesion is good at adjacent locations. Therefore, a spot fix is appropriate. All loose brick material must be scraped off. In some instances, this may result in an abrupt profile change requiring the brick to be resurfaced. Repair of the brick itself was not included in Able’s scope of work.

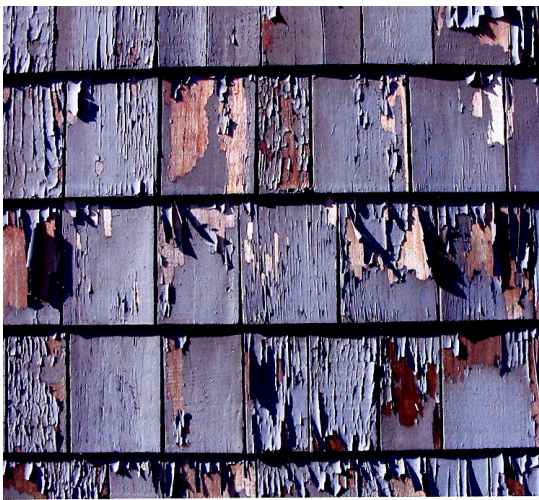
Photo 3

Best Painting Service spray-applied one coat of a fast drying exterior primer and two coats of acrylic satin house paint to the exterior rough sawn shingles. Within weeks, extensive peeling had occurred as shown in photo 3. Examination of the rear of the peeling paint revealed that wood fibers were attached to and embedded in the paint (photo 4). The cause of the peeling was the combination of product selection and application method. Rough sawn wood, especially when weathered, has loosely attached wood fibers on the surface. The use of a slow drying primer, or “long oil”, would have extended the drying time which would encourage penetration into the wood establishing good adhesion. However, since it was a quick drying primer, then the act of spray applying would have compromised the adhesion. When a fast drying primer is sprayed, it tends to lay on the surface to which it is applied. The mechanical action of brushing or rolling tends to work the primer into the surface of the wood establishing better adhesion. The two finish coats of acrylic paint exert a large amount of surface stress upon the primer and the peeling resulted.

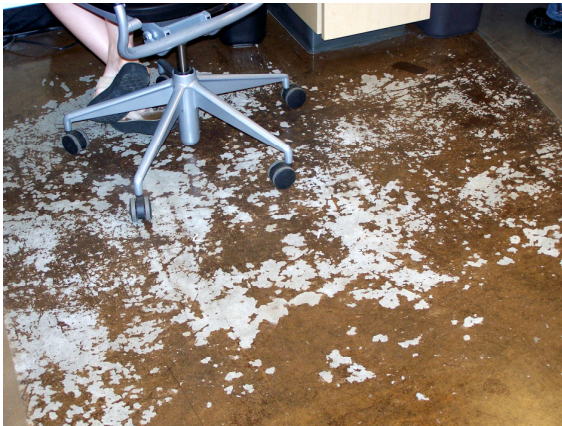
Photo 5

Dedicated Coatings Inc. painted a new car showroom facility. The concrete floors were acid etched and a concrete stain and sealer system was applied. Soon after the facility was put into operation, there was extensive delamination of the stain as shown in photo 5. Several adhesion pull tests were performed. The test results showed that the stain was well adhered to the surface of the concrete, but when failure occurred, some of the concrete was attached to the rear of the stain (photo 6).

Laitance is a thin layer of new concrete that consists of fine particles at the surface due to the upward migration of water during the placement and curing process. This concrete layer is of low strength and should be removed when surface preparation is performed. Unfortunately, the acid etching performed was not aggressive enough to remove this low strength layer. For this reason, the more aggressive method of shot blasting is often preferable.
