SOMETIMES YOU HAVE TO LOOK DEEP TO FIND THE ANSWER

By Bob Cusumano

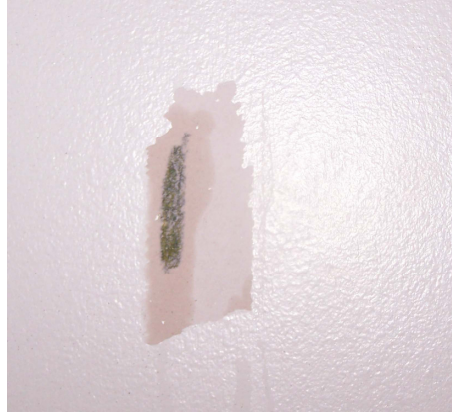
The adhesion of the paint to its plaster substrate was tested in general accordance with ASTM D3359, Adhesion by Tape Test, Method A. Incisions were made through the coating in an X pattern. Permacell adhesive tape was firmly applied to the area and then sharply removed. The adhesion of the coating was then evaluated by the amount of material that is removed. The adhesion tests yielded poor results on all of the samples using acrylic primers. Photo 1 shows a typical test result where the paint was removed under the entire area of the tape. The results were somewhat better when alkyd primers were used; however, when these primers received the acrylic finish coats, the results were again poor.

pH is a measure of the acidity or alkalinity of a substance. A pH of 7 indicates neutrality. pH readings decreasing from 7 indicate increasingly acidic conditions. Likewise, pH readings increasing from 7 indicate increasingly alkaline conditions. The pH on the surface of the plaster was measured by marking the area with a pH pencil, moistening the area with distilled water, and comparing the color to the pH chart. The pH of the bare plaster was found to be in the range of 8 to 9, which is not highly alkaline. pH tests were also conducted on the plaster exposed during the adhesion tests (also shown in photo 1) and were found to be only slightly alkaline.

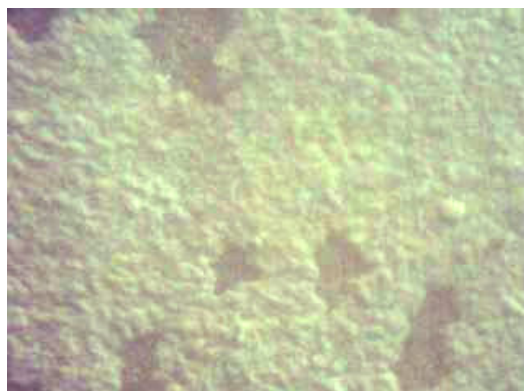
Photo 2

All of the adhesion test samples were optically examined using a stereo zoom microscope. It was observed that there was a thin layer of plaster attached to the rear of the delaminated paint in all instances. Adhesion tests were then conducted on unpainted plaster surfaces. Again, a thin layer of plaster was removed with the tape as shown in photo 2.

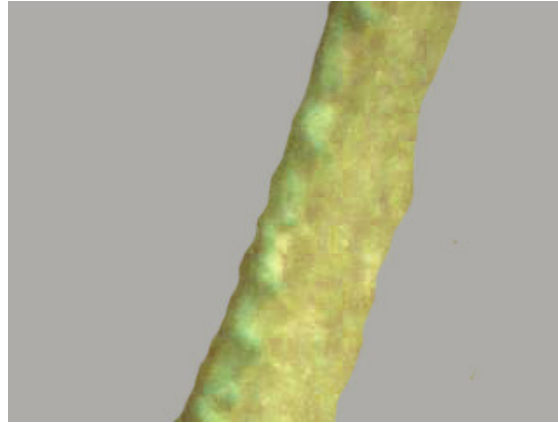
paint only was then measured in the same manner. The thickness of the plaster was determined by subtracting the thickness of the paint only from the thickness of the paint and plaster for each sample. The thickness of the plaster layer attached to the rear of the paint extracted during adhesion tests ranged from 0.9 to 4.5 mils.

A drop of green food dye was placed on the rear of an adhesion test sample. The dye penetrated through the porous plaster and stopped at the paint interface. Photo 3 shows a cross section of the sample where both the plaster layer and coating layer are easily discernable.
