# Coatings Consultants, Inc.

## THE RAILINGS THAT DIDN'T AGE GRACEFULLY

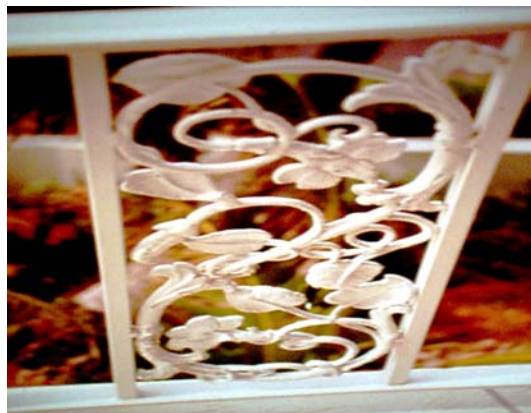
Photo 1

Upon visiting the site, we noted that the railings consisted of wrought aluminum uprights and horizontal rails to which cast aluminum decorative panels had been welded (photo #1).

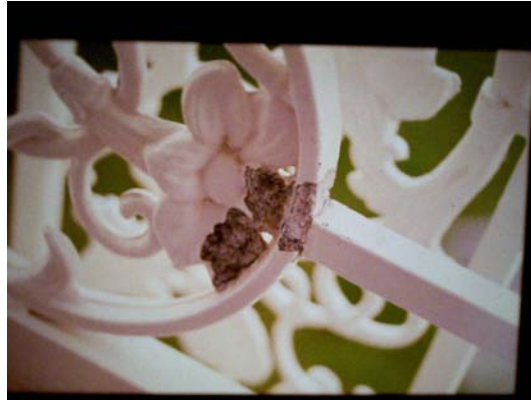
Photo 2

After examining several areas, it was determined that the decorative cast panels had widespread paint delamination and were severely corroding. In fact, so much so, that in several instances the metal could be crushed and broken with your bare hands. There was a white powder present beneath the delaminating paint, later analyzed to consist primarily of aluminum oxide, a common corrosion product and the metal rough and discolored as shown in photo #2. It was also noted that the adjacent wrought aluminum rails had blisters in the paint. When the blisters were broken, the aluminum beneath was bright and shiny with no evidence of corrosion or the white aluminum oxide powder.

This combination of observations suggested that galvanic corrosion was occurring. Galvanic corrosion occurs when two different metals are physically or electrically connected and are placed in an electrolyte, that is a liquid that is capable of carrying an electric current. Batteries are based on this scientific phenomenon. Based on their metallurgical properties, one of the metals will be less "noble" than the other and will become the anode. Corrosion and consumption of the metal occurs at the anode. The other, more "noble" metal becomes the cathode. At the cathode, no corrosion occurs. Instead, the chemical reaction that takes place causes hydrogen gas to form. In our instance, it appeared that the cast decorative aluminum panels were the anodes and the wrought uprights and rails were the cathodes. The moist, marine atmosphere present at this south Florida location served as the electrolyte. The fact that the panels were welded to the rails and uprights put them in electrical continuity with each other, so galvanic corrosion was indeed possible.

This explained the reason why the corrosion was occurring, but did not explain its severity. Since all of the metal components were aluminum, there would only be a slight metallurgical difference between the wrought rails and uprights and the cast panels. Yet, the severe corrosion experienced suggested that additional factors came into play. It was decided that a trip to the aluminum shop where the railings had been stripped and repainted might prove productive. Indeed, it did.

Most aluminum alloys contain traces of other metals to improve their physical properties. Usually, these metals are evenly distributed throughout the metal. Metals consist of individual grains, which are usually of microscopic size. One exception is bright galvanizing, where the individual grains of zinc are easily seen. In our case, the aluminum panels contained copper. When subjected to prolonged heat followed by natural cooling, a process known as aging can occur. During aging, the copper migrated from within the individual grains to the grain boundaries. This caused each individual metal grain to become a galvanic cell with the resultant metal oxidation being called intergranular corrosion. In this case the temperatures achieved and the time of exposure was sufficient to result in aging and explained the catastrophic destruction of the panels.

The remedy was an expensive one and unfortunately cost the contractor a bundle. All of the decorative panels were cut out of the railings and discarded. New panels of a particular composition were ordered. The new panels had tabs for fastening them to the rails rather than being welded. It was important to electrically isolate the panels from the rails so that galvanic corrosion would not again occur. To accomplish this, a stainless steel screw was encased in a teflon sleeves containing a built in washer at each end. This assembly was passed through a hole in each tab. When the nut was tightened, the screw and nut were electrically isolated from the panel, with the result being that the panel and the adjacent rail were also electrically isolated. Under this condition, galvanic corrosion cannot occur. The schematic drawing shows how this was accomplished.
