# Coatings Consultants, Inc.

## TOO MUCH OF A GOOD THING CAN BE BAD

By Bob Cusumano

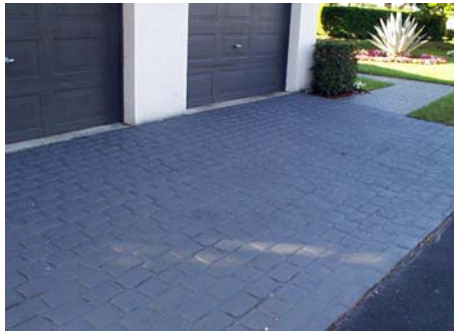
Photo 1

The sample driveways were visually examined for overall appearance and surface profile. Photos #1 and #2 show this area. The maximum difference in surface profile was measured using a pit gauge and was determined to be 40 mils.

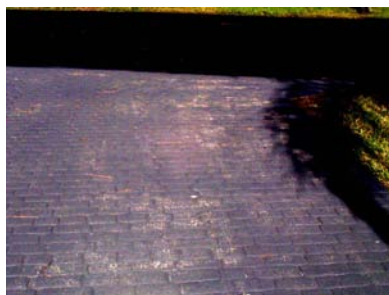
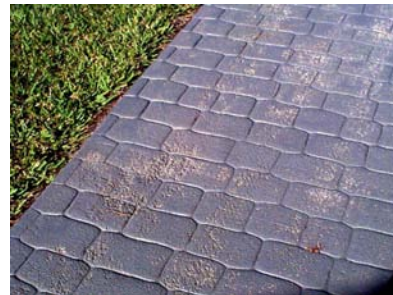
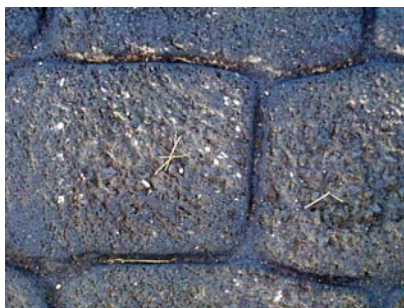
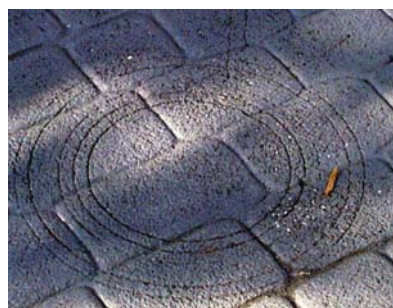
The forty additional driveways that were water-blasted were compared to the samples to determine their acceptability. Of these, it was our opinion that thirty-three were unacceptable due to substantial areas where the surface profile was deep and varied greatly. At many locations the concrete peaks created by the extreme profile were broken by contact with the tires when car were driven on them. The maximum surface profile on these driveways varied from 180 mils to 470 mils. Twenty-nine have a profile difference of at least 240 mils, six times that of the sample driveways. An additional five water-blasted driveways had most areas resembling the sample driveways but have isolated areas where the surface profile is unacceptable. Photos #3, #4, #5 and #6 show some of the deep, variable profile created. It was our opinion that only two of the forty driveways were acceptable and resembled the sample driveways.

The painting contractor should have recognized that the profile created by the water blasting was excessive for the thin concrete stain finishing system that he was to apply. The repair would have been much less costly had the need for a concrete resurfacer been recognized prior to staining. Because it was not, the cost of the original staining and the cost of sandblasting to remove that stain prior to re-coating were extra, costly steps in the repair process.

It was determined that the following steps must be taken to repair the condition of the driveways at Golfer’s Heaven:

1. The recently applied stain must be removed from all driveways considered defective. The most effective method of accomplishing this is wet abrasive blasting.

2. The next step is to apply a high strength cementitious surfacer to the water-blasted areas. This surfacer must be applied in a manner to fill the extreme porosity and texture created by the water-blasting. The surface profile created must resemble that of adjacent areas.

3. Finally, the resurfaced areas must be coated with two coats of concrete stain.

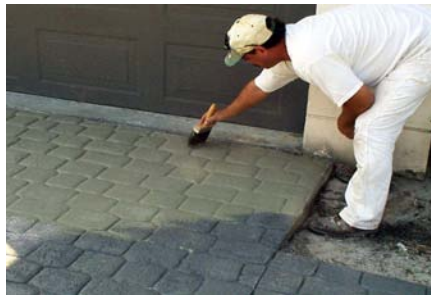
Photo 7

Because the re-surfacing operation is very labor intensive (photo #7), the total cost of repair exceeded the original cost of the water-blasting and staining.
