Coatings Consultants, Inc.

TOO MUCH OF A GOOD THING CAN BE BAD

By Bob Cusumano

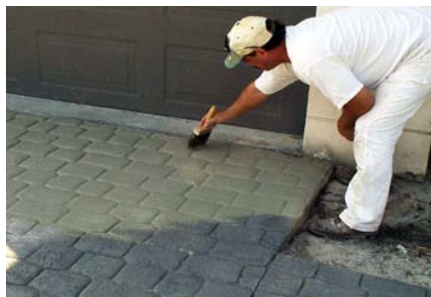
Photo 7

Because the re-surfacing operation is very labor intensive (photo #7), the total cost of repair exceeded the original cost of the water-blasting and staining.

2. The next step is to apply a high strength cementitious surfacer to the water-blasted areas. This surfacer must be applied in a manner to fill the extreme porosity and texture created by the water-blasting. The surface profile created must resemble that of adjacent areas.
