WATER, WATER EVERYWHERE

By Bob Cusumano

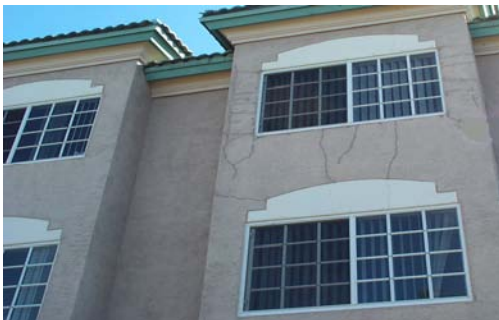
Photo 1

A Florida painting contractor was the successful bidder on a new apartment complex. The project consisted of 18 two and three story buildings, with the exteriors constructed principally of cement plaster or stucco (photo #1). The project was completed without incident. Within the first year, the owner/developer of the project began receiving complaints from several tenants concerning water intrusion into the apartments. A consulting firm made a site inspection and then the fur started flying. Several subcontractors that had worked on the project were sued, including the painting contractor. The allegations against the painting contractor included defective workmanship resulting in an unacceptable appearance, failure to apply the specified paint coats, thus allowing water infiltration through the stucco walls, and failure to apply caulking to adequately waterproof the buildings. Several hundred thousand dollars in damages was alleged. The painting contractor's insurance company became involved in the case and contacted our firm for consultation.

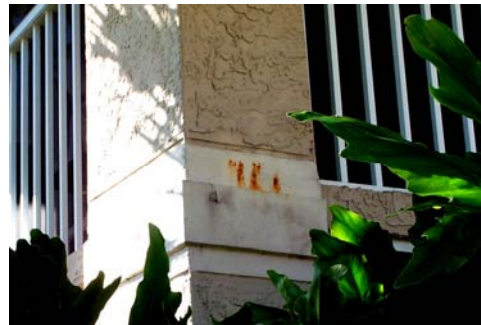
Photo 2

Upon visiting the project, it was apparent that there indeed had been extensive water intrusion. Many areas of the building had visible indications such as efflorescence, alkali burn and rusting of metal stucco accessories (photo #2).

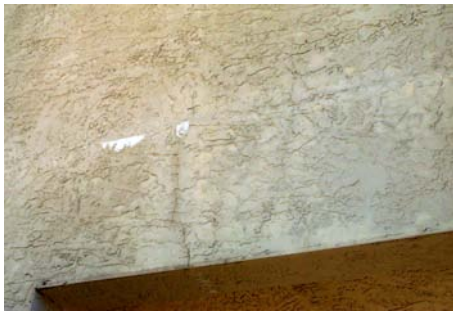
Photo 3

Efflorescence is the formation of crystalline salt deposits on a surface due to the migration of water through a cementitious substrate like stucco, concrete, or block. The vertical rundown pattern obvious in the photo #3 is typical of this condition. In some instances this will cause the paint to delaminate, however when the affected paint film is very permeable, or when voids exist in the coating film, then the occurrence of efflorescence does not cause delamination of the paint.

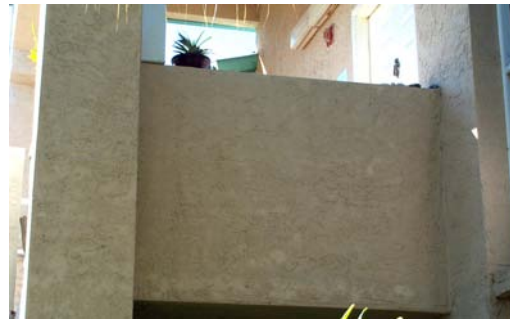
Photo 4

All cementitious materials have alkali present. When moisture migrates through the stucco, the alkali salts concentrate immediately beneath the paint film. This condition results in a degradation of the resin and/or pigment in the paint film and occurs when the paint is in contact with an alkaline substrate. Alkali burn occurs when the resin and/or pigment in the paint degrade and "bleach out". The affected area has a blotchy, mottled appearance (photo #4).

A pH survey was conducted on the buildings. It was found that at areas where the paint was mottled and discolored, the stucco immediately beneath the paint was highly alkaline, being in the range of 11 through 13. At other areas where the paint was not discolored, the pH was in the expected range of 8 to 10. This indicates that the discoloration of the paint is indeed due to alkali burn caused by water intrusion, rather than a defect in the paint itself.

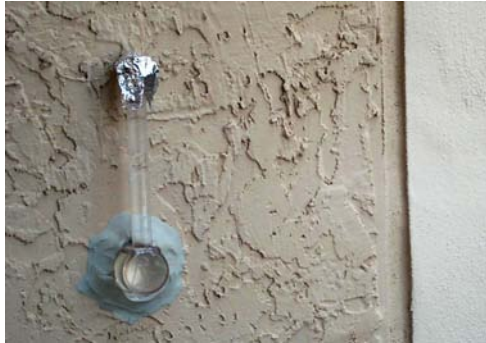
Photo 5

Next, the tendency for the painted stucco to absorb water was tested. Rilem tubes, clear plastic tubes with graduated volumetric markings, were attached to the buildings using a special putty (photo #5). The Rilem tubes were filled with distilled water and the time of the day was noted. A piece of plastic wrap was placed over each container so that the water could not evaporate nor

could water enter by rainfall or from the sprinkler system. The amount of water that had penetrated from the Rilem tubes into the wall was recorded after specific time interval and the absorption rates were calculated. All absorption rates on stucco surfaces where no cracks were present were found to be extremely low and at locations where stucco cracks were present, were found to be high. These tests proved that the water is not penetrating through the painted stucco but is instead intruding through defects in the exterior building envelope.

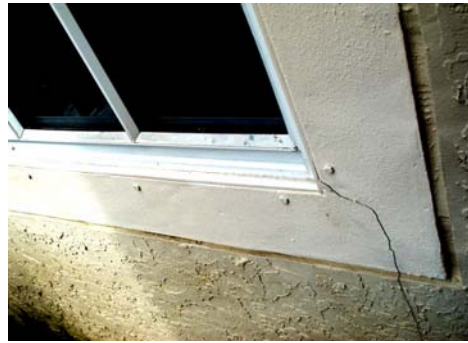
Photo 6

The caulking at the perimeter of doors and windows was examined and although some crazing was evident, there was no adhesive failure or splitting that would allow water penetration. The water intrusion experienced at these locations could instead be readily attributed to stucco cracks adjacent to the windows such as shown in photograph #6.

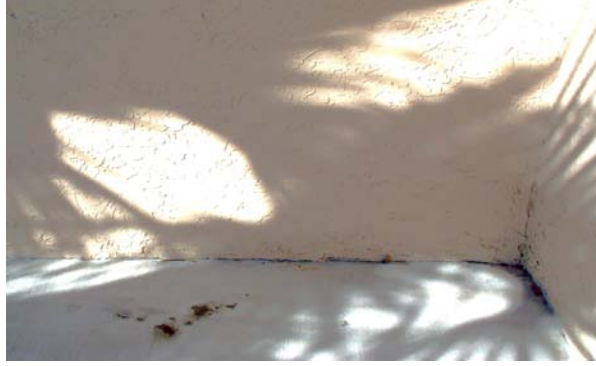
Photo 7

That's because even though the painting contractor's estimate only priced out caulking the perimeter of exterior doors and windows, there was a caulking section in the specifications that indicated that additional locations needed to be caulked including all junctures of dissimilar materials, all building penetrations, and all 90 degree junctures. Further, the painting contractor signed a contract indicating that all painting work and related caulking would be performed. Unfortunately this vague term caused the painting contractor to assume some liability for water intrusion. For example, as shown in photo #7, water would puddle on some concrete floors. Since the wall to floor intersections had not been caulked, water could penetrate into the buildings.
