Coatings Consultants, Inc.

ORGANIC IS NOT ALWAYS GOOD

By Bob Cusumano

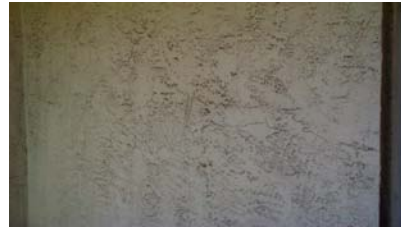
Photo 1

Mildew growth, such as that shown in photo #1 is often confused with dirt collection on soft exterior coatings like elastomerics as shown in photo #2. One way to discern between the two is to look at the surface through a magnifying glass.

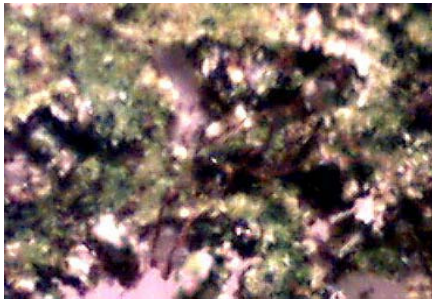
Photo 3

Mildew has a fluffy appearance that is sometimes cob web like with thin threads visible. Photo #3 shows mildew under a low power microscope. Surface dirt, on the other hand, is composed of individual isolated dark dots as illustrated by photo #4.

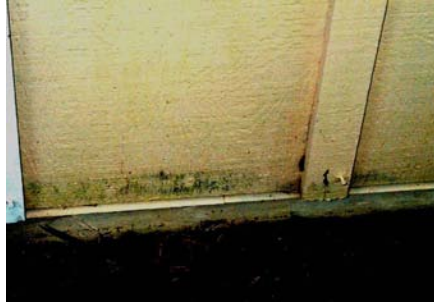
Photo 5

Unfortunately, mildew can grow into paint and sometimes through it into the substrate below. On some occasions you may be faced with situations where another painting contractor has painted over mildew without first treating it as indicated above. This situation is depicted in photo #5. When that occurs, the existing coating must be removed, often best accomplished by chemical stripping. After removing the existing paint, the mildew needs to be killed before repainting is performed.

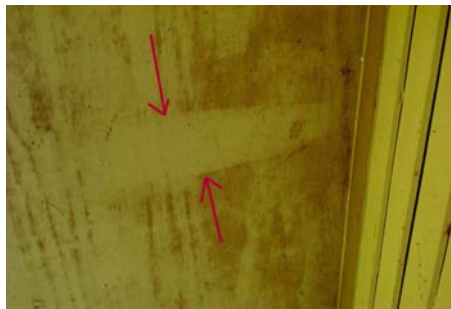
Photo 6

In a recent case, wood soffits were found to be exhibiting wide scale mildew growth after a short period of time. Photo #6 shows a typical section of the building.

The specified paint system consisted of one coat of alkyd primer followed by two coats of acrylic gloss. It was determined that instead of the specified system, the painting contractor applied two coats of flat latex. The "stripe" is a seam between plywood boards that has been floated with joint compound. Note that the mildew generally follows the grain pattern of the wood. Also note the relatively clean "stripe" between the red arrows. It is our opinion that these phenomena have occurred due to the fact that the flat latex applied does not adequately seal the wood and therefore moisture present from "green wood" can escape, encouraging the growth of mildew. Due to the added thickness at locations where the joint compound was applied, mildew growth was less likely to occur. There is no question that the location of this building and the "swampy" surrounding conditions contribute to the mildew conditions encountered. We recommend that when remedial painting is performed, the following be considered. Mildewcides are chemicals that are added to paint to retard mildew growth. For many years, mercury and other heavy metals were effective for this purpose. When the use of these mildewcides was discontinued to safety hazards, effective alternatives had to be developed. Mildewcides are expensive and add significant cost to the particular paint product to which they are added. Manufacturers always try to answer the question "how much is enough" attempting to balance the increased cost with product quality. This is particularly difficult when paint products are manufactured for use at all areas of the country that have different temperature and humidity environments. In some instances, it is warranted to purchase and add extra mildewcide to the paint being applied due to the location of the building.

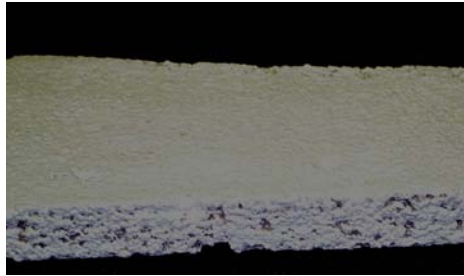
Photo 7

We are often asked to examine mildew growth on painted concrete roof tiles. The mildew growth usually emanates from rough, unfilled, and unpainted porous areas particularly at the butt edges of the tiles as shown in photo #7.

The roughness and "porosity" of the edges varies from tile to tile are rough as result of the manufacture of the tiles. Mildew growth is enhanced at these pores because the areas remain wet longer and collect dirt. The method of paint application sometimes plays a role in the growth of mildew on the roof tiles. The paint usually is applied by spraying. This method causes the paint to lie on the surface and is not "worked" into voids and crevices. When the application is by brush or roller, the paint is forced into pores and surface defects and complete coverage is attained. Applying the paint by spray and then back-rolling or back-brushing is satisfactory. This is especially important on the butt edges of the tiles. In some cases filling the butt edges with a cementitious slurry prior to painting would eliminate the problem.
