## PITFALLS OF PAINTING STUCCO

By Bob Cusumano

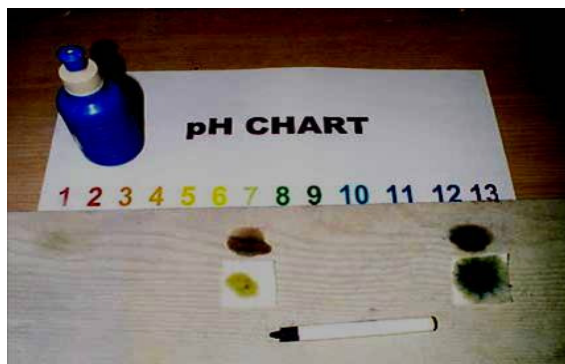
Photo 1

So how do we measure pH? Well, the most prevalent method is to use a pH pencil and distilled water. These pencils may be obtained from companies that distribute paint testing equipment. The pH on the surface of the stucco is measured by wetting the area with distilled water, stroking the moistened surface with a pH pencil, waiting approximately 30 seconds and then comparing the developed color to the pH chart provided with the pencil (photo 1). pH papers and electronic measuring devices are also available.

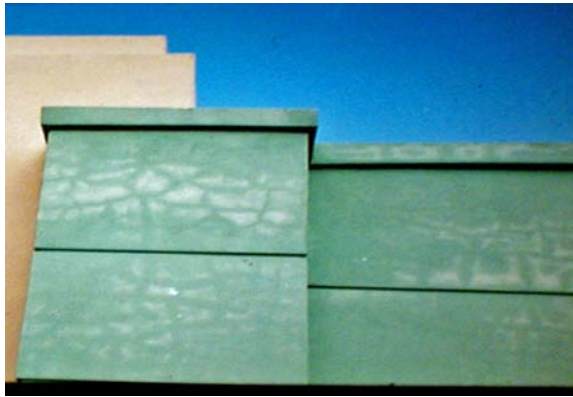
Photo 2

What happens if we paint a stucco that is too alkaline (commonly called “hot”)? Depending upon the properties of the paint used, including the type of resin and pigments employed, the paint may suffer from a condition known as alkali burn. Alkali burn occurs when the resin and or pigments in the paint degrade and "bleach out". The surface will usually have a mottled or blotchy appearance and often premature chalking occurs. This condition is shown in photo 2.

Moisture also plays a role in alkali burn and therefore should also be measured using a moisture meter before painting stucco. You may measure the surface pH of the stucco and find it in a normal range. However, if the stucco still has a high moisture content due to retained moisture and is painted, or if water can enter the painted stucco through cracks, the pH of the stucco immediately behind the paint may increase as alkaline salts migrate toward the surface, but are blocked by the paint film. For this reason when stucco cracks are present, the area immediately adjacent to the cracks is relatively unaffected because the moisture can easily escape through the crack rather than migrate through the stucco thus raising the alkalinity. This is the cause of the spider web appearance.

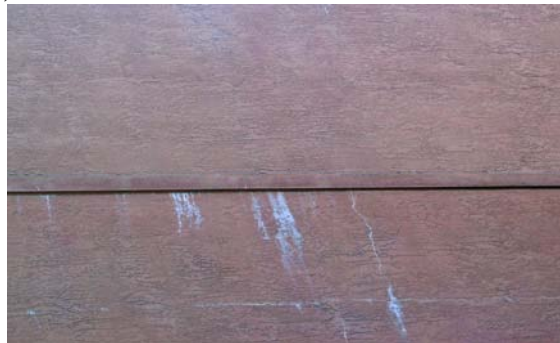
Photo 3

Two other conditions related to alkalinity and moisture may also occur. Efflorescence is the formation of crystalline salt deposits, usually white, on a surface of the paint due to the migration of water through the cementitious substrate. The vertical rundown pattern obvious in the photo 3 is typical of this condition. When the affected paint film is very permeable, or when voids exist in the coating film, then the occurrence of efflorescence does not cause delamination of the paint.

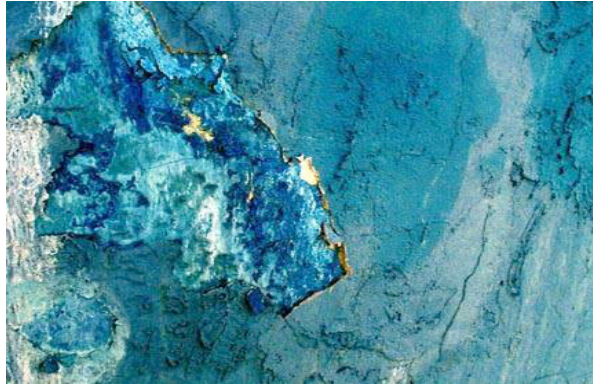
Photo 4

Saponification is the chemical degradation of a coating due to high alkalinity and moisture and occurs when the resin of the paint used is not alkali resistant. The coating resin is attacked from the rear side and loses its physical characteristics by turning into a soap-like material. Blisters usually occur which have a “mushy” consistency. When the saponified coating dries, it becomes brittle and loses its adhesion. This phenomenon is shown in photo 4.

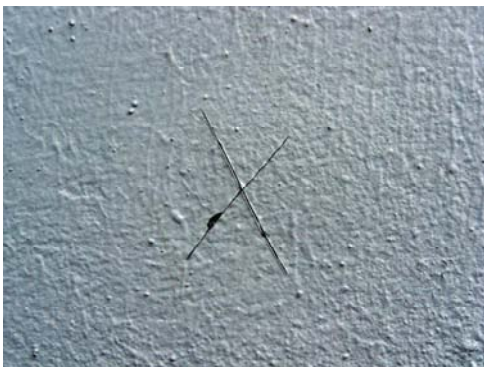
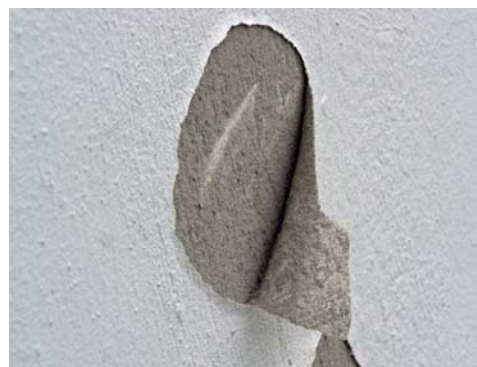
Just checking the surface alkalinity and moisture content of the stucco is not enough. Recently, a painting contract was painting the exterior stucco on a twenty story hotel. A high build acrylic paint was being used. Before painting, the paint manufacturer measured the surface pH of the stucco and found it to be approximately 9 at all locations. The painting contractor measured the moisture content with a moisture meter and found it to be very low, so he proceeded to paint the exterior walls. Within a few weeks, certain parts of the wall began to exhibit peeling paint. Those of you who are regular readers of this column know that I stress the importance of adhesion tests ad nauseum. Well, here's another example of why I do. Adhesion tests should yield results similar to that shown in photo 5. Unfortunately, more than half of the adhesion tests performed on this building had results similar to those depicted in photo 6. Note that there is a thin layer of stucco attached to the rear of the delaminated paint. In this instance, an unstable stucco substrate is the cause of the coating delamination. Even though the surface pH and moisture content of the stucco were proper, the surface in many places was soft and friable rather than hard. When high build products are applied, the weight and stress created may exceed the cohesive strength of the material to which they are applied. When this occurs, the unfortunate result is peeling paint.
