## HERE'S SOMETHING TO RAIL ABOUT

By Bob Cusumano

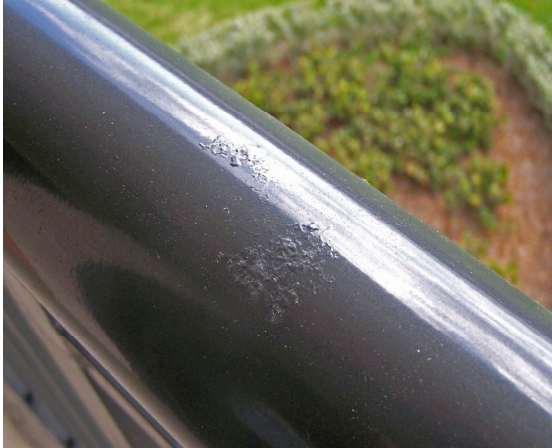
On railings that are located in coastal areas, the common cause of coating failure is corrosion. If an AAMA 2603 coating has been applied which offers a low level of protection, then moisture and chlorides can penetrate through defects and thin areas of the coating, causing the aluminum beneath the coating to corrode. Because the corrosion product occupies more space than the non-corroded aluminum, the coating is lifted and the process is accelerated as more moisture and salt enter and undercut the paint film. Photo 1 shows the early stages of this condition. Photo 2 shows a cross section through an aluminum picket. Notice that the coating is very thin at the corner due to surface tension.

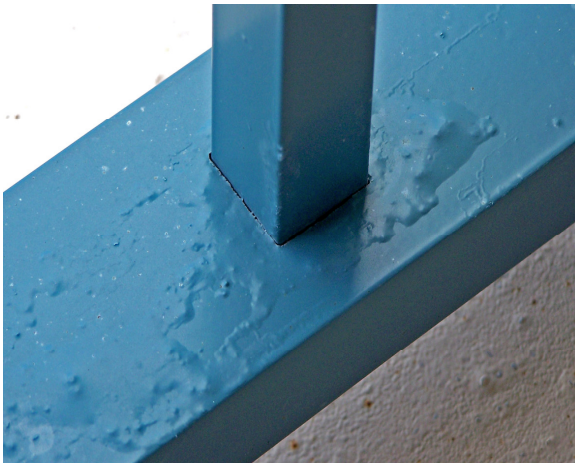
Photo 3

In other instances, corrosion is initiated at breaks in the coating where different pieces of metal are joined. This is shown where pickets penetrate into the bottom rail as in photo 3 and where pieces of handrail join in photo 4. The use of a coating resistant primer can greatly enhance the performance of factory applied coatings.

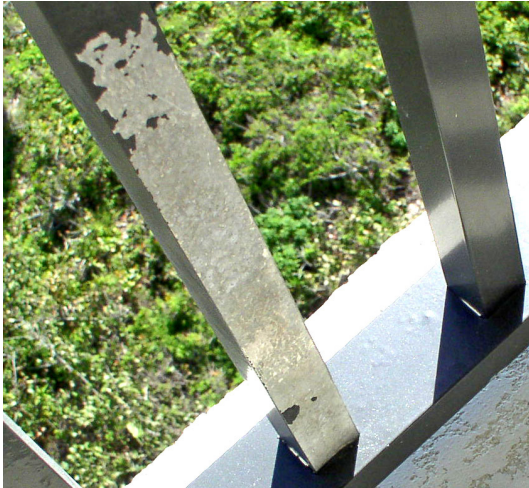
Photo 5

When proper surface preparation has not been performed, then delamination of the coating to bright metal may occur. This condition is shown in photo 5. When corrosion is the cause of delamination, then only affected areas show poor adhesion test results. When improper surface preparation is the cause of the delamination, then non-corroded surfaces exhibit poor adhesion test results.
