Coatings Consultants, Inc.

PITFALLS OF PAINTING STUCCO

By Bob Cusumano

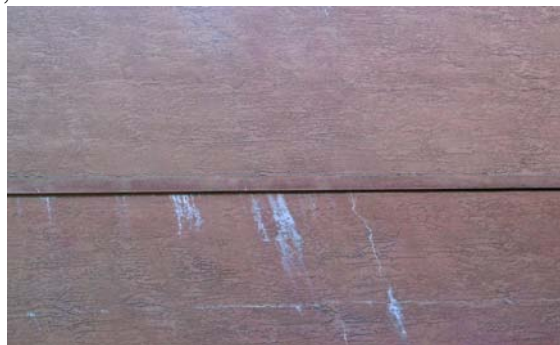
Photo 3

Two other conditions related to alkalinity and moisture may also occur. Efflorescence is the formation of crystalline salt deposits, usually white, on a surface of the paint due to the migration of water through the cementitious substrate. The vertical rundown pattern obvious in the photo 3 is typical of this condition. When the affected paint film is very permeable, or when voids exist in the coating film, then the occurrence of efflorescence does not cause delamination of the paint.

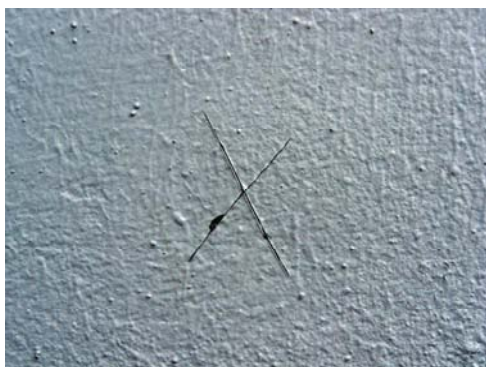
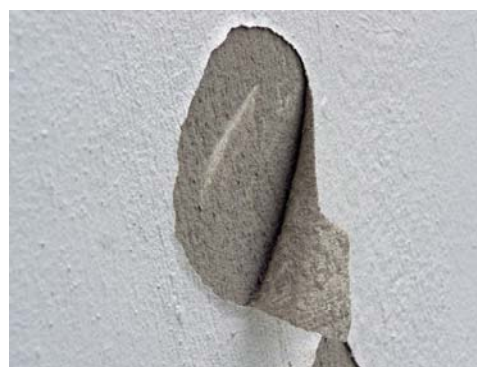
Photo 5

Just checking the surface alkalinity and moisture content of the stucco is not enough. Recently, a painting contract was painting the exterior stucco on a twenty story hotel. A high build acrylic paint was being used. Before painting, the paint manufacturer measured the surface pH of the stucco and found it to be approximately 9 at all locations. The painting contractor measured the moisture content with a moisture meter and found it to be very low, so he proceeded to paint the exterior walls. Within a few weeks, certain parts of the wall began to exhibit peeling paint. Those of you who are regular readers of this column know that I stress the importance of adhesion tests ad nauseum. Well, here's another example of why I do. Adhesion tests should yield results similar to that shown in photo 5. Unfortunately, more than half of the adhesion tests performed on this building had results similar to those depicted in photo 6. Note that there is a thin layer of stucco attached to the rear of the delaminated paint. In this instance, an unstable stucco substrate is the cause of the coating delamination. Even though the surface pH and moisture content of the stucco were proper, the surface in many places was soft and friable rather than hard. When high build products are applied, the weight and stress created may exceed the cohesive strength of the material to which they are applied. When this occurs, the unfortunate result is peeling paint.
