# Coatings Consultants, Inc.

## WHEN THOUGHTS TURN TO SPRING

By Bob Cusmano

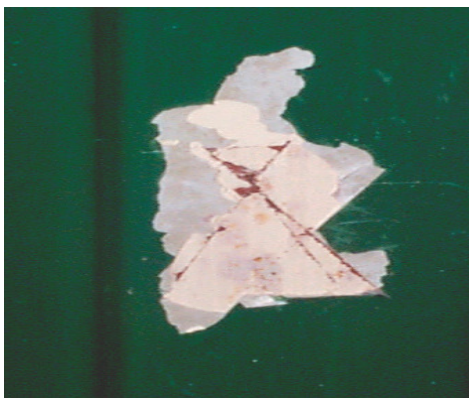
Photo 1

It is of utmost importance that we adequately assess the surfaces that we intend to repaint. Any peeling areas should be noted as requiring extra preparation. However, even if there is no visible signs of paint delamination, tests should be conducted to assure that the existing paint is not poorly or marginally adhered. For this we turn to the cross hatch adhesion test that I have previously spoken so much about. To perform this test, make an X cut with a razor blade into the substrate. Clean any contaminants off the surface and apply a strong masking tape over the X. Rub it on so that it is well adhered. Then sharply remove the tape and see what comes off. If nothing comes off, then the surface appears to be sound. If some paint layers are removed during the test and some remain on the building, then the layers removed during the test may need to be removed before repainting is performed. A second adhesion test should be performed at the same location to determine if even more previously applied paint coats are poorly adhered. If all of the paint coats are removed to expose the bare substrate, then stripping of all previously applied paint is necessary. Photo #1 shows the result of a cross hatch adhesion test where a green topcoat and gray layer beneath it have been removed exposing a white coat of paint.

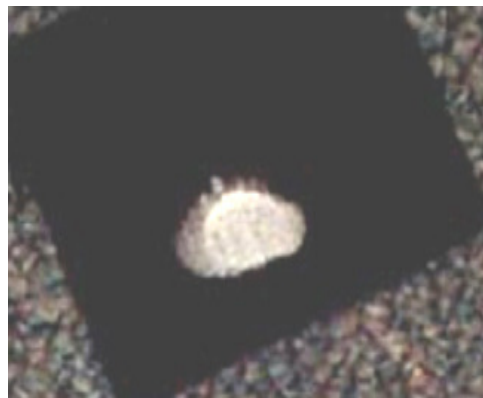
Photo 2

When the ultimate surface to be painted has been determined to be structurally sound, then that surface should be checked for contaminants that can interfere with the adhesion of additionally applied paint. The degree of surface chalk should be assessed by wiping a contrasting colored cloth across the surface (photo #2). Cleaning methods and the selection of an appropriate primer should depend upon the amount of chalk present.

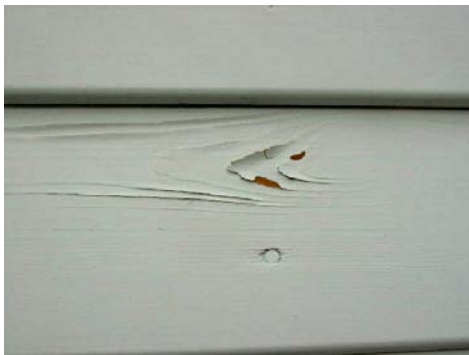
Photo 3

Excessive substrate moisture and water intrusion should always be a consideration when an exterior inspection is performed. An electronic moisture meter can be an effective tool in detecting whether or not this condition exists. Physical signs to look for include water stains, peeling paint (photo #3), alkali burn (photo #4), and efflorescence (photo #5).

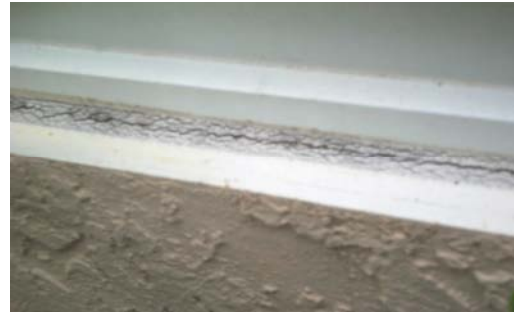
Photo 6

should be checked for adhesion, flexibility, and cracking (photo #6). Where found to be defective, it should be removed and replaced.
