# Coatings Consultants, Inc.

## MAKE SURE IT STICKS

By Bob Cusumano

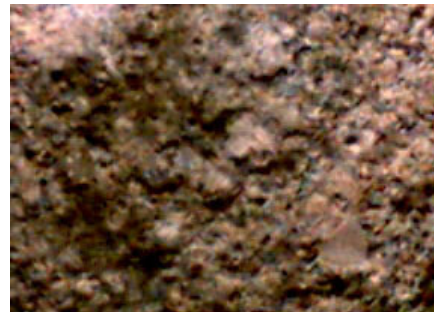
Photo 2

Laitance is a thin layer on the surface of new concrete that consists of fine particles due to the upward migration of water during the placement and curing process and often occurs on concrete floors. This concrete layer is of low strength and should be removed when surface preparation is performed. Photo #2 shows a microscopic view of laitance on the rear of delaminated paint.

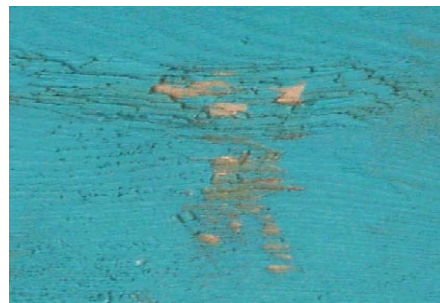
Photo 4

Rough sawn wood, especially when weathered, has loosely attached wood fibers on the surface. If a latex paint or solid stain is spray applied to this surface, then poor adhesion often results due to the paint laying on the surface and loose fibers detaching from the wood carrying the paint with it. This condition is shown in the adhesion test result in photo #4. When that same wood was painted by brush instead of sprayed (photo #5) the adhesion was improved because the paint was "worked into" the substrate.

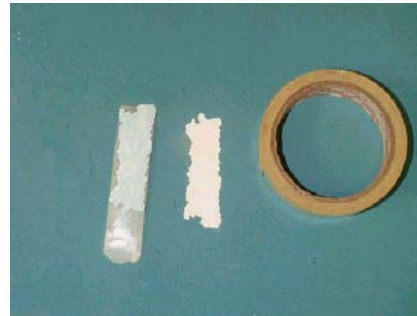
Photo 6

Probably, more gallons of paint are applied to drywall and gypsum board than any other surface and adhesion problems can even occur here. After joint compound is applied to the nail heads and joints it is often sanded to produce a smooth finish. The dust created from this operation should be removed prior to painting so that adhesion can be achieved on a sound, clean surface. Drywall texture or orange peel is sometimes applied to the surface of drywall prior to painting. If an acrylic binder is not added in sufficient quantity, then the resultant texture may have a chalky surface and low cohesive strength. Photo #6 illustrates that white texture is attached to the rear of the blue paint that delaminated during the adhesion test.

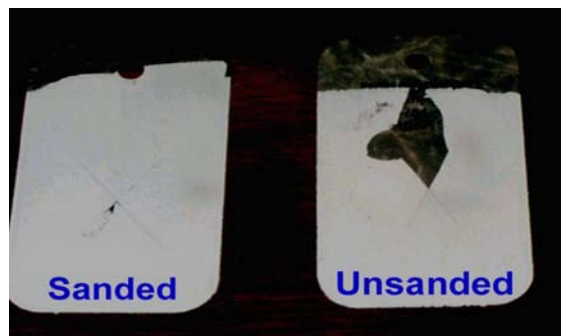
Photo 7

In repaint situations, chalk, dirt, mildew, wax, oil, salt, and other surface contaminants may interfere with the establishment of good coating adhesion and must be removed using appropriate measures. Hard, smooth surfaces should be sanded and wiped clean to promote good mechanical adhesion. Photo #7 shows that this is an effective procedure. But in repaint situations, not only does the surface being painted need to be evaluated but also the adhesion of the existing coatings. It is common that when additional coats are applied to a previously painted surface that has marginal paint adhesion, the additional weight and stress produced may cause delamination, especially when applying top of the line products.
