## A WHITER SHADE OF PALE

By Bob Cusumano

This case involves color change on the exterior of an assisted living facility that was constructed in the year 2000. The specifications called for the use of two coats of acrylic flat finish paint on exterior concrete and stucco surfaces. The color selected for the exterior walls was a bright yellow from an interior color chart.

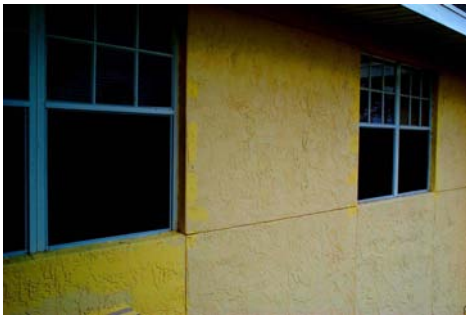
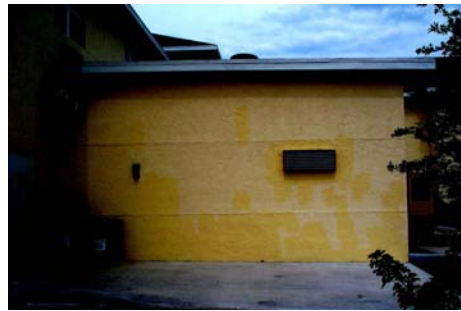
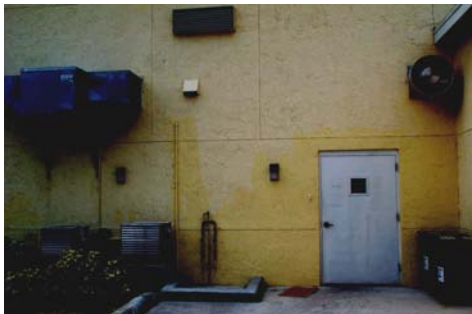
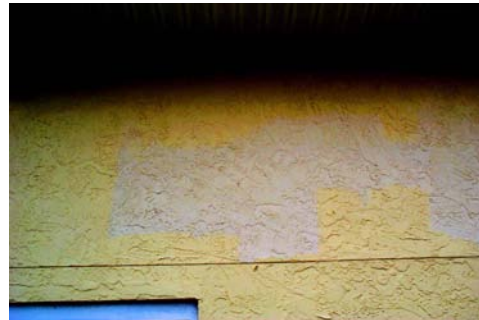
Approximately four months after completion of the exterior painting, the painting contractor returned to perform extensive touch up. About six months later, the owner called to complain that the building was unacceptable due to non-uniformity of color. The building manager explained that the "blotchy" paint appearance was not originally apparent, but has gotten progressively worse since first noticed. A visual inspection of the exterior walls indicated that certain wall areas were distinctively different in color than other areas. These conditions are depicted in photographs #1 through #4.

It is clear that the drastic color difference between dark yellow areas and light yellow areas as shown in the photos is due to some areas being repainted after the original application. The discoloration has a very distinct rectangular "block" pattern which is a result of touching up with a roller. This condition was confirmed by microscopic observation where the darker yellow coat could be clearly identified as overlaying the lighter yellow color. This was also confirmed in thickness tests.

Obviously, immediately after the touch up painting was performed, this drastic color difference did not exist. If it did, the painter would not continue to repaint with a color that did not match. Chemical oxidation tests performed on the new touchup paint indicated that it has a stable pigment. Therefore, it appears that the originally applied paint faded over time due to containing unstable pigments, whereas the touch up paint did not. Therefore, the color difference between the original unstable paint and the new stable touchup paint became obvious.

1. Always save enough paint from the original batch to perform touch up painting.

2. Make sure that colors selected for use are stable enough to be used in exterior exposures
3. Order one or two factory batches, rather than several small store tinted batches when possible for a large project.
4. Don't assume that different batches or paints will "weather" in the same fashion.

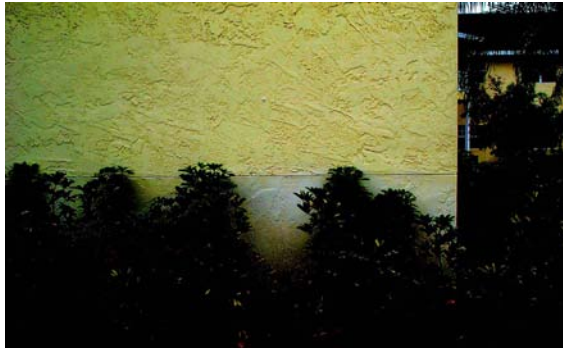
Photo 5

A few ground level wall panels were nearly white in color as shown in photo #5.

This condition was found only at a few locations and only on very low building panels. It is our understanding that maintenance personnel may have applied chemicals for the eradication of rust stains that may have contributed to the degradation of the paint at these areas. Based on the chalk tests performed, "chalking" is not the major reason cause of paint discoloration, except at these few areas.
